# INSPECTION REPORT

For the Property at:  
**1600 N. PAULINA ST.**  
CHICAGO, IL 60622

Prepared for: MARTHA BLACK and CARL FINN  
Inspection Date: Monday, September 9, 2013  
Prepared by: Thomas Jansson

RE: Report No. 1392, v.2  
1600 N. Paulina St.  
Chicago, IL  
60622

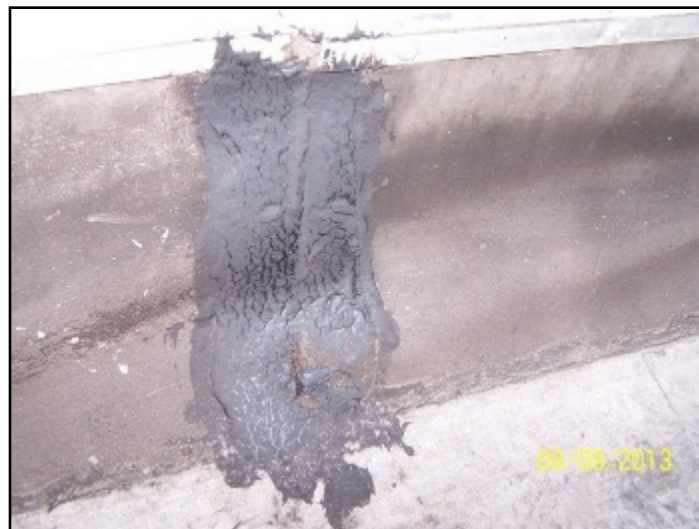
Open seams have been patched over with roofing cement. This appears to be a temporary solution that could fail at any time. Review and repair by licensed roofing contractor is recommended prior to closing.

*Patched*

**Task:** Further review by licensed roofing contractor; Repair

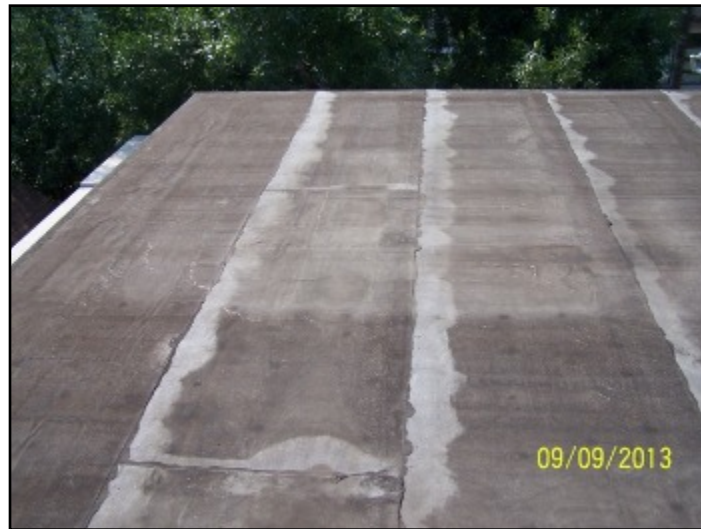
**Condition:** • [No UV protection \(paint, granules, etc.\)](#)

*No UV protection (paint, granules, etc.)*

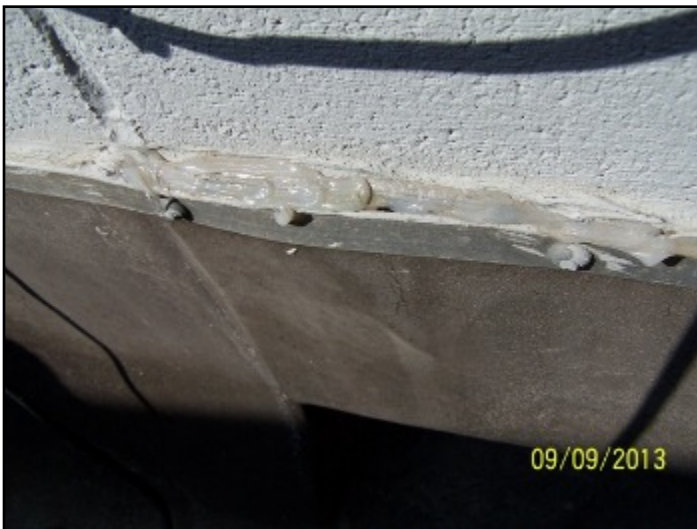
*Previous repair to roof flashing*

Frequent inspection and maintenance of this type of flashing is necessary. The caulk has a tendency to dry and crack, leading to roofing leaks. An annual maintenance check by a licensed roofing contractor is recommended.

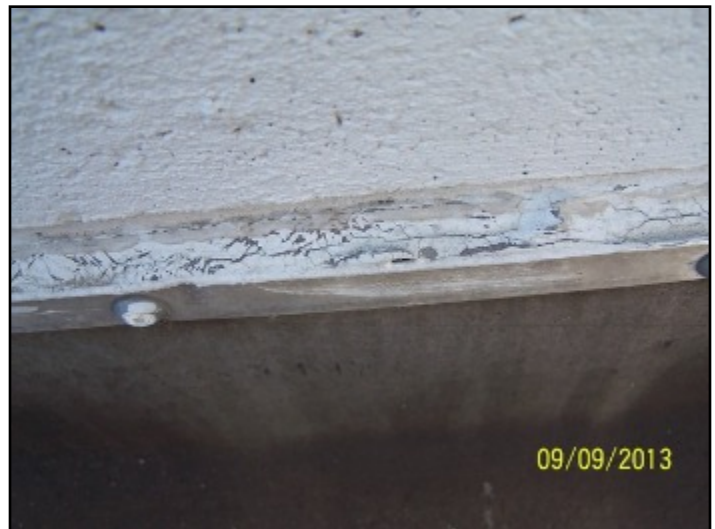
*Service needed at roof flashing*

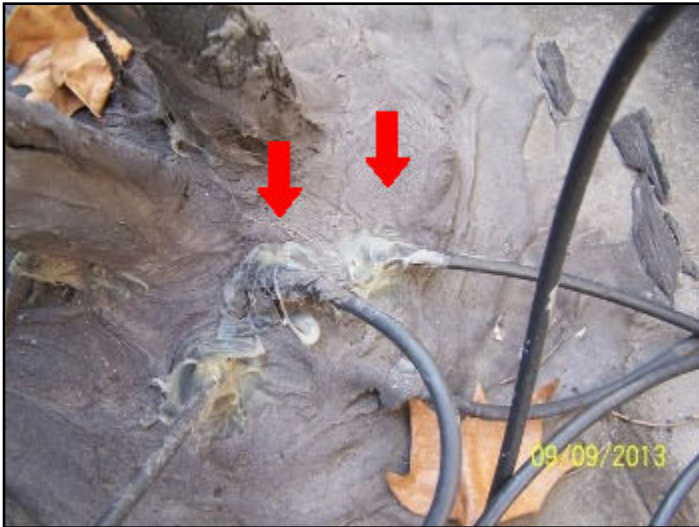
No flashing at air conditioning lines. Chance of water entry. Area appeared free of leaks, but is considered vulnerable. The addition of a pitch pan is recommended. Consult with licensed roofer prior to closing.

*No flashing, previous repair, vulnerable area*

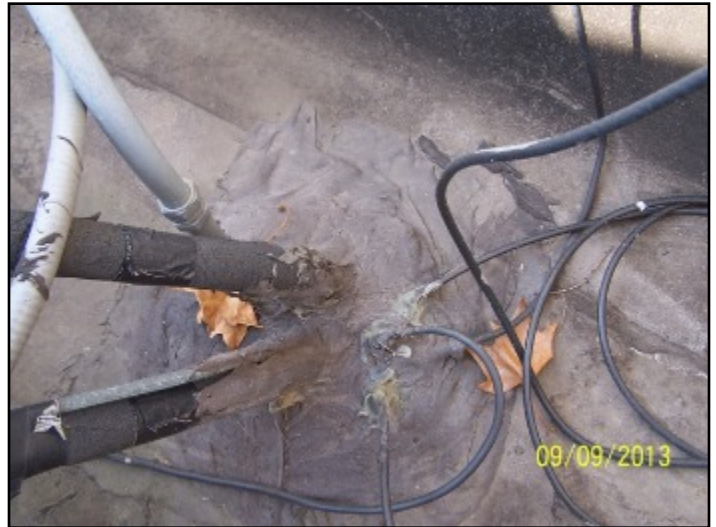
*Missing flashing; vulnerable to leakage*

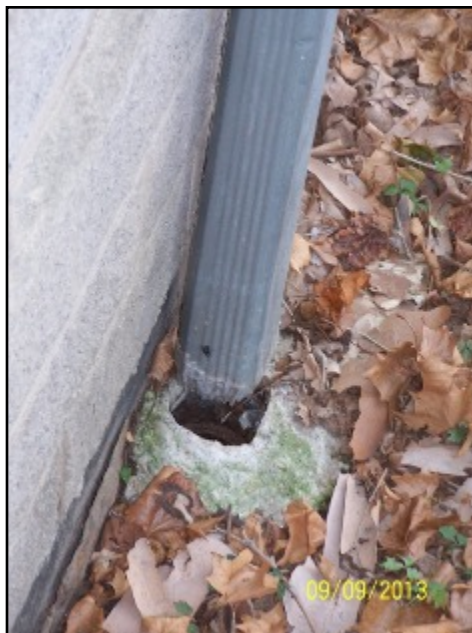
Condition: • [Loose connections](#)

*Loose connection; may cause basement leaks*

Task: Correct

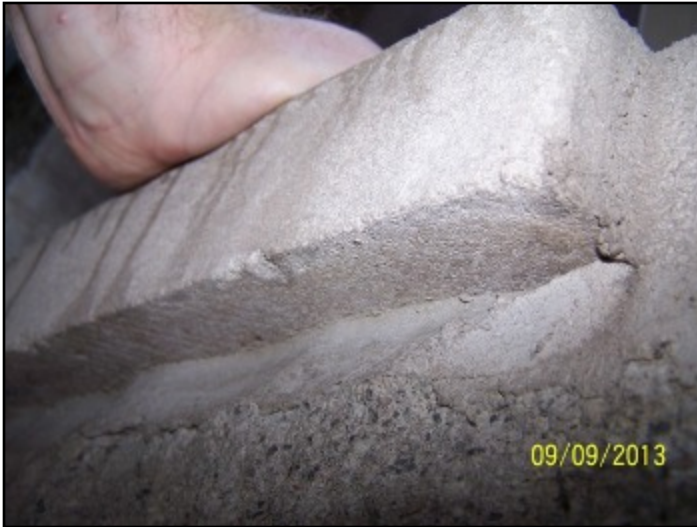
*No flashing visible beneath sills throughout*

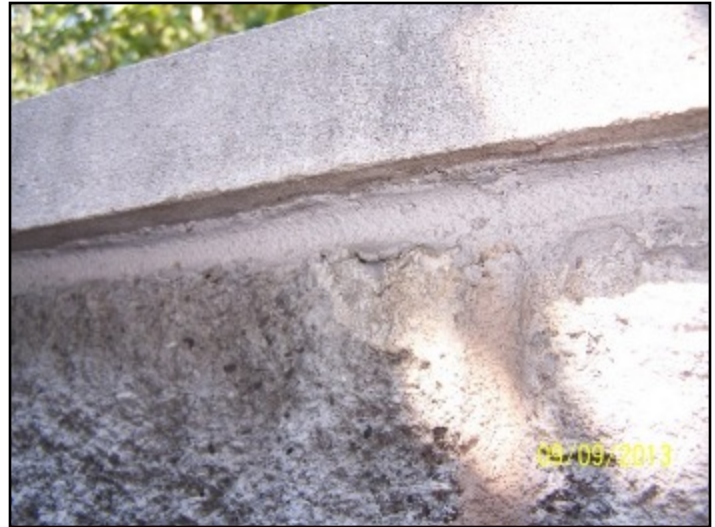
**Condition:** • No flashing or drip edge noted at parapet cap. Lack of these features has been known to lead to water entering the wall cavity in this type of construction. No significant interior water penetration was observed at time of inspection.

*No flashing seen under parapet caps thru-out*

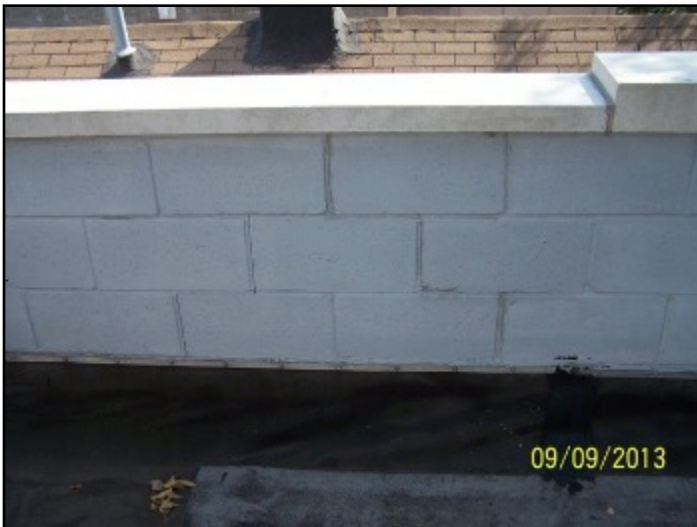
Mortar cracks noted at parapet and at parapet caps. All exterior masonry should be sealed and waterproofed by licensed and insured masonry specialist prior to closing.

*Mortar deterioration at parapet wall*

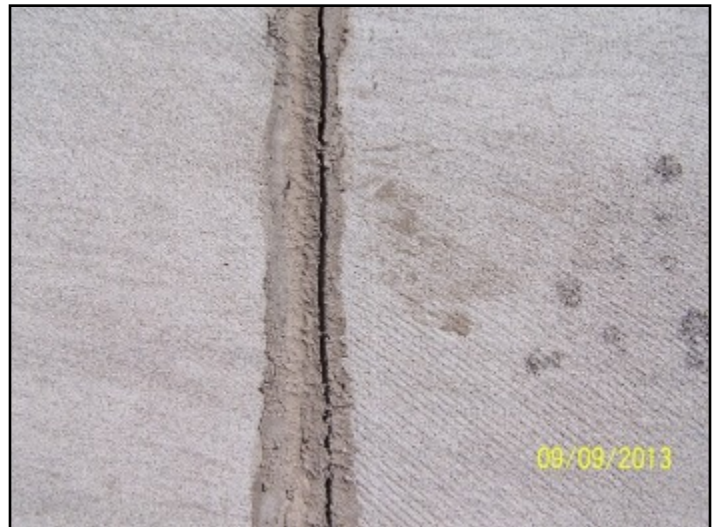
*Mortar cracks at parapet caps*

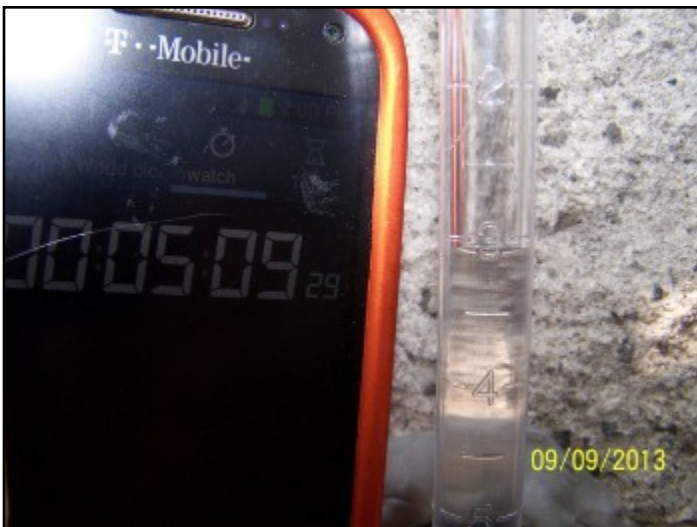
Mortar cracks were noted throughout exterior. Even small cracks such as these can allow significant amounts of water into the structure. Testing with RILEM tubes at a representative section of the south wall revealed that the exterior is extremely vulnerable to water entry. Further evaluation and repair by licensed and insured split-faced block specialist is strongly recommended prior to closing.

*Waterproofing needed*

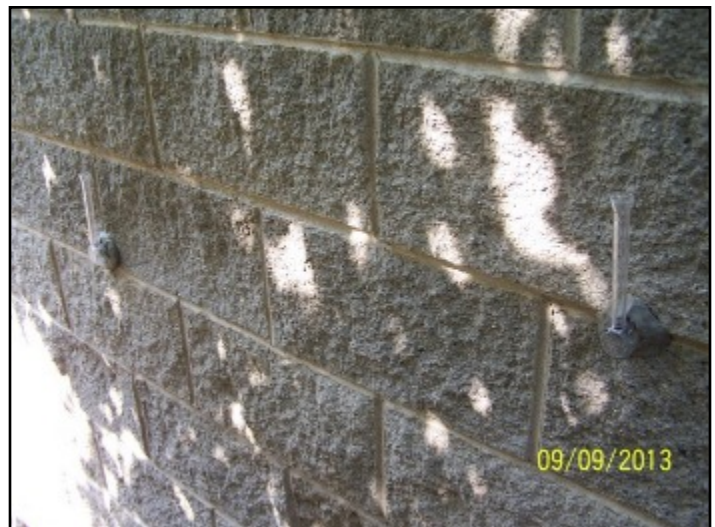
*RILEM testing*

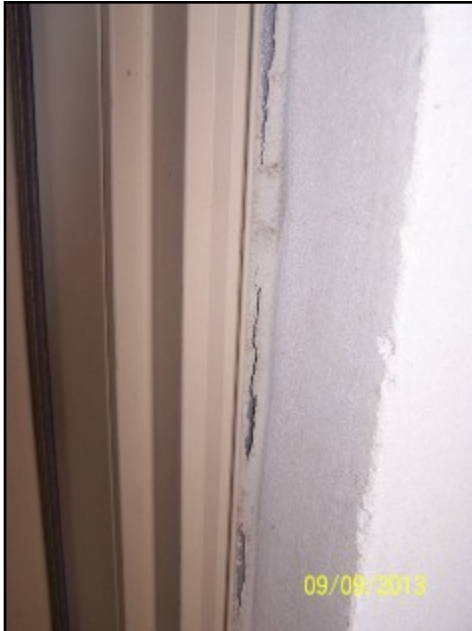
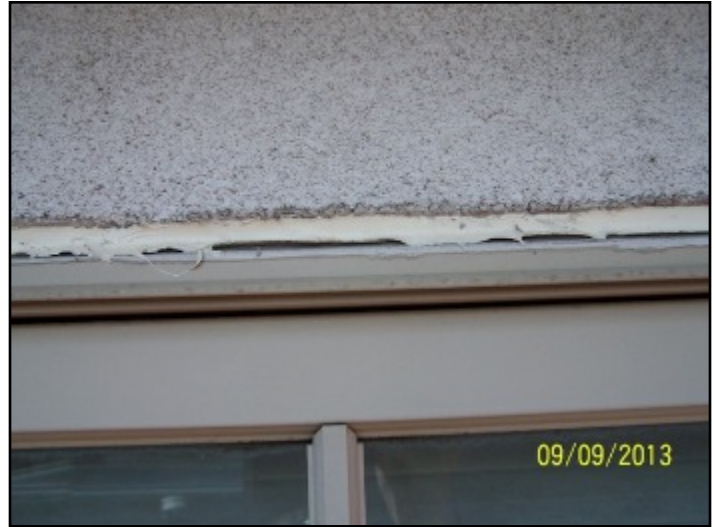
**Condition:** • [Caulking loose, missing or deteriorated](#)

*Caulk deterioration throughout*

**Task:** Repair

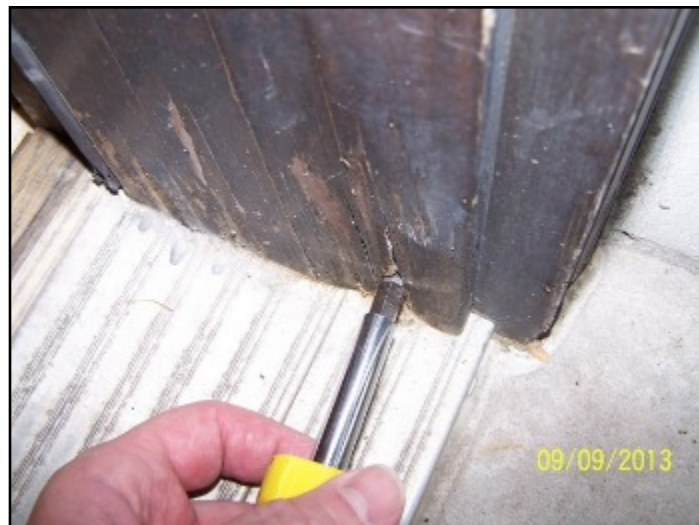
Bottom portion of front door jamb is beginning to rot. Repair or replacement by licensed, skilled finish carpenter is recommended prior to closing.

*Rot: front door jamb exterior*

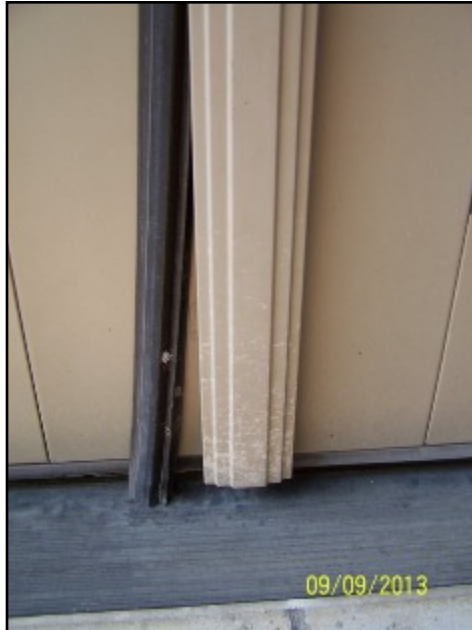
Loose, damaged weather-stripping at rear patio doors. Chance of drafts, chance of water and pest entry. Have doors repaired as needed prior to closing.

*Loose, damaged weather-stripping*

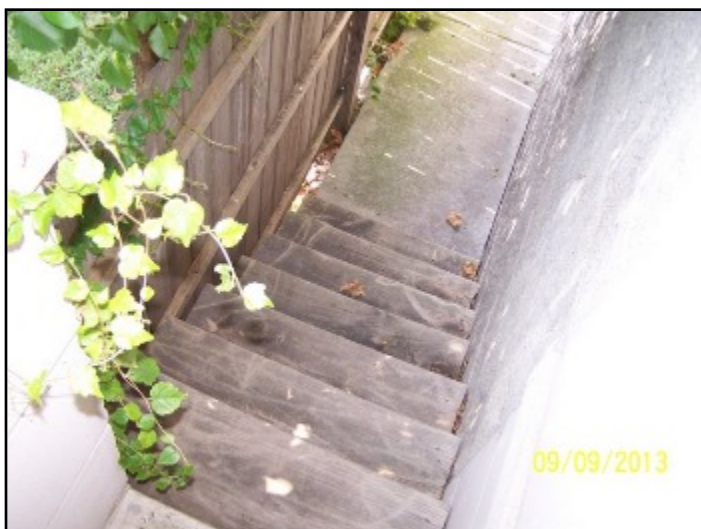
**Condition:** • [Missing](#)

*Missing handrail*

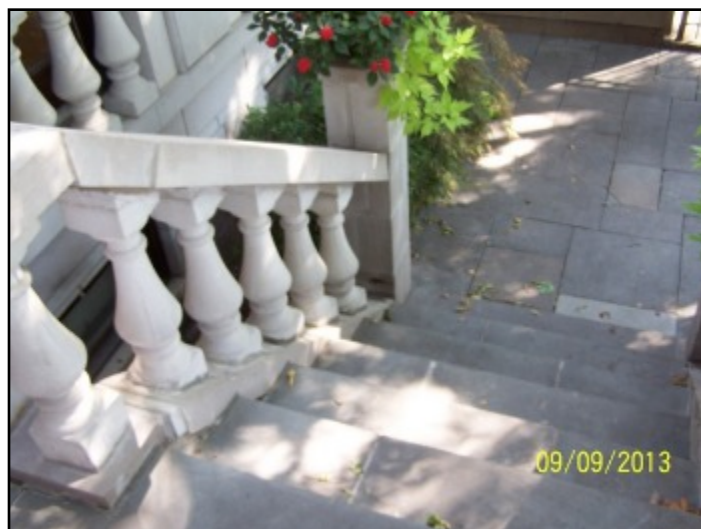
*Handrail not graspable*

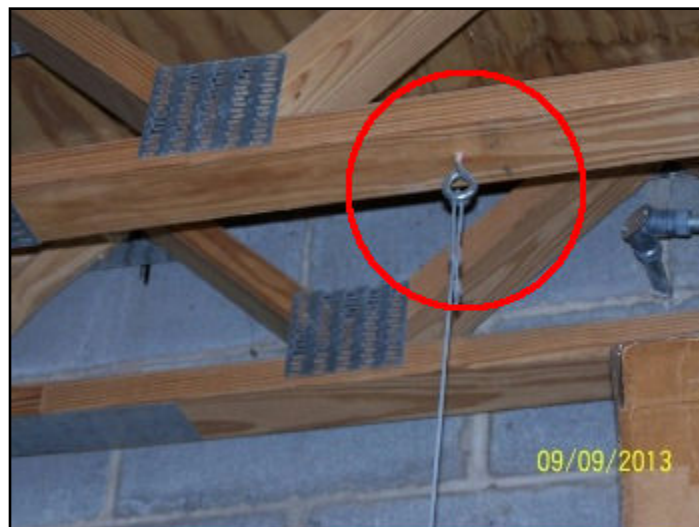
Point loads have been attached to trusses for storage shelving support. Please be aware that trusses are engineered components; they may or may not be designed to bear weight from below. Further evaluation by licensed structural engineer, or removal of point loads is recommended prior to closing.

*Concentrated loads on trusses*

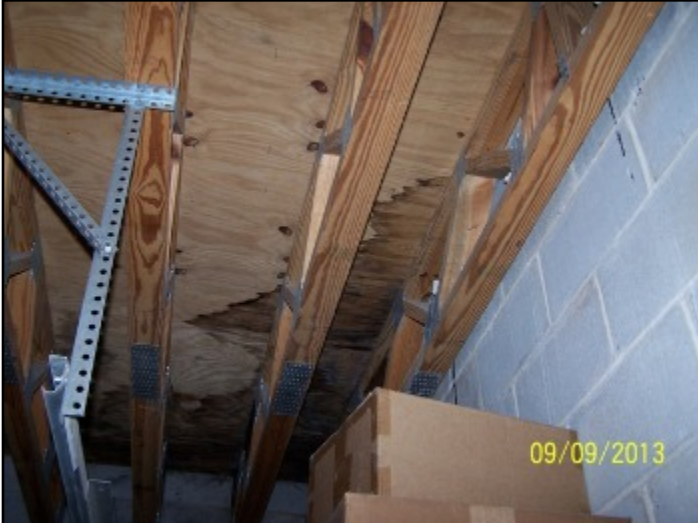
Garage: Water-stained sheathing

Water stains, elevated moisture levels noted at garage roof sheathing, southeast. Replace damaged sheathing when repairing roof.

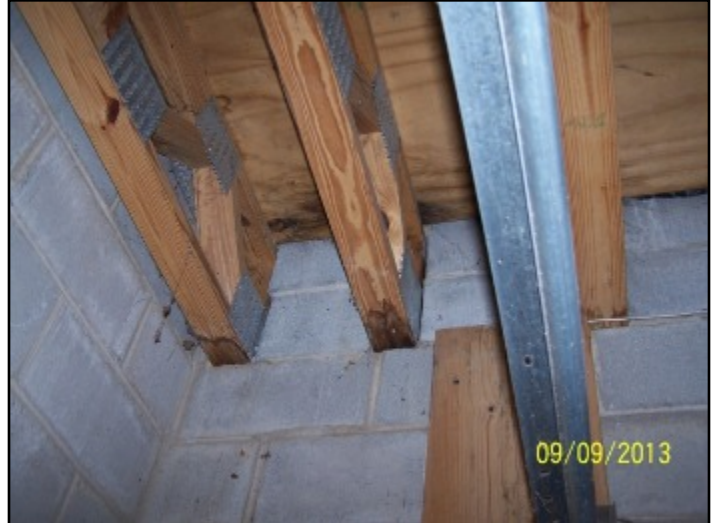
Water stains @ trusses throughout garage

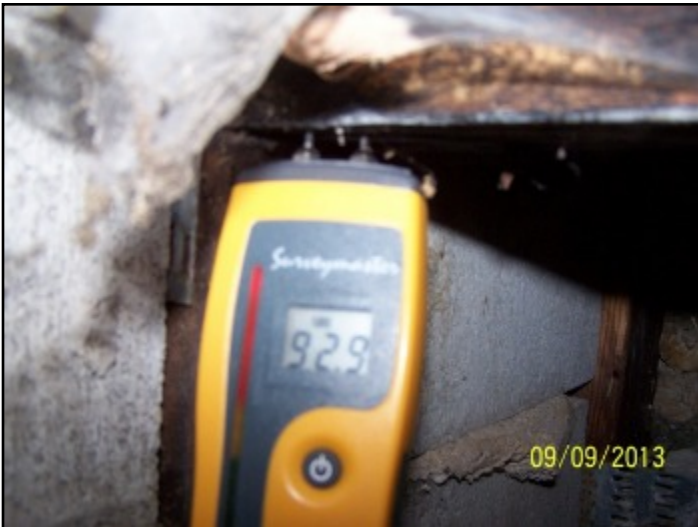
Active water entry: Saturated Truss

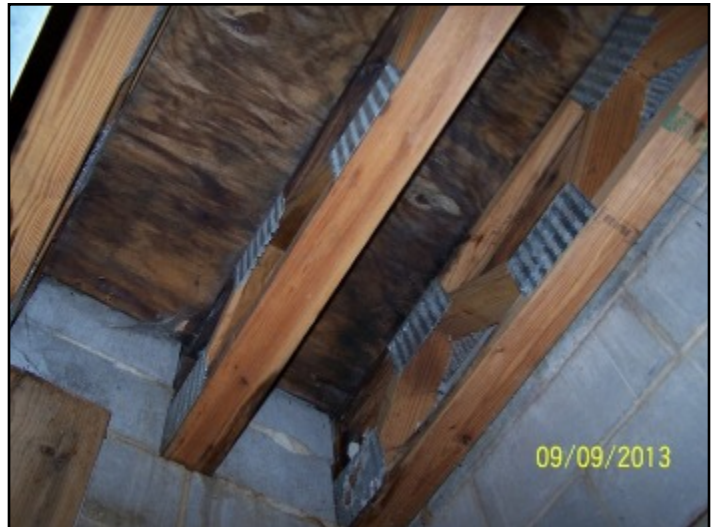
Garage: Area of structural water damage

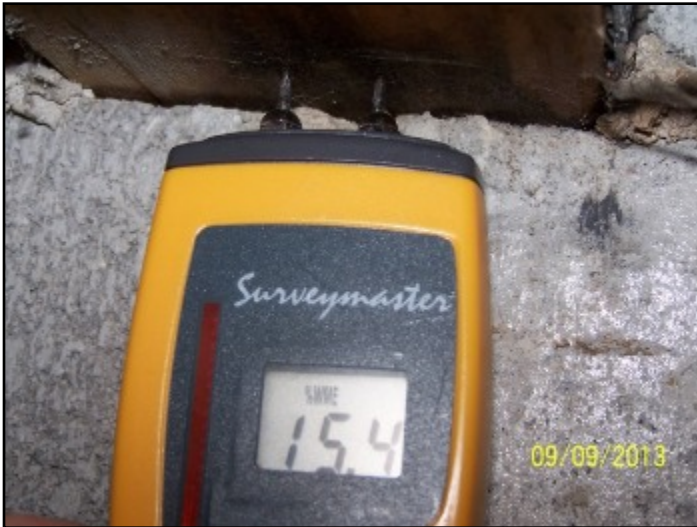
*Elevated moisture level; monitor; ongoing*

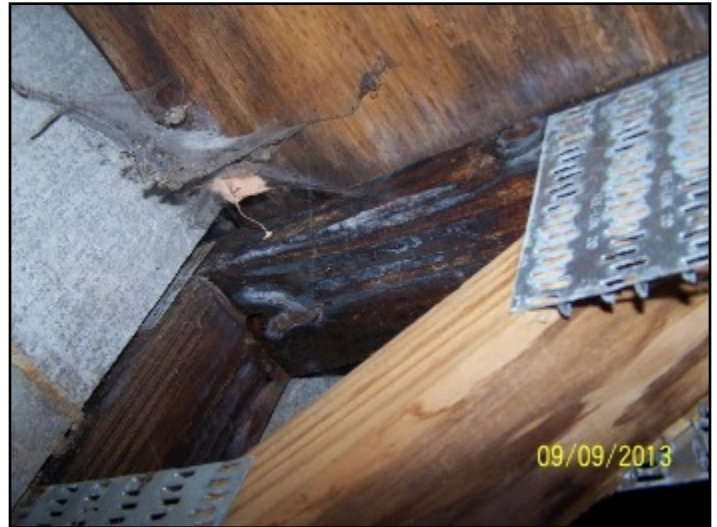
Rot noted at garage truss. Further evaluation is recommended when repairing garage roof. Replacement of damaged truss(es) may be necessary. Have trusses evaluated by licensed roofer or licensed structural engineer prior to closing.

*Garage: Rotting Truss*

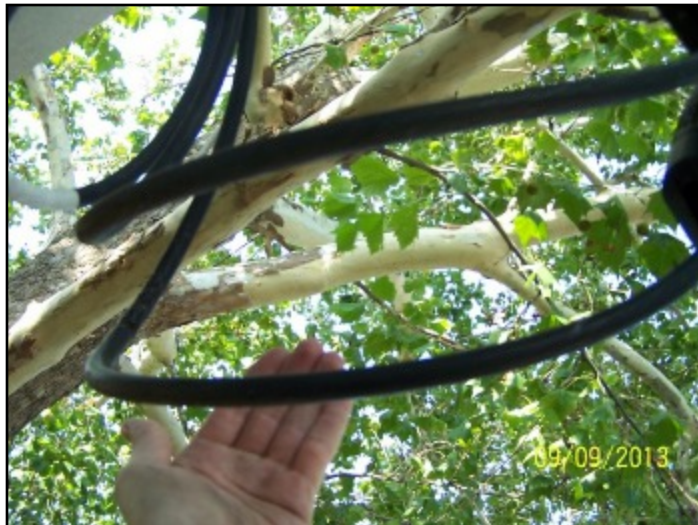
Improper clearance from balcony. 5 foot horizontal clearance is recommended. Have service entrance moved when correcting meter base issue noted elsewhere in this section.

*Improper clearance from balcony to elec svc*

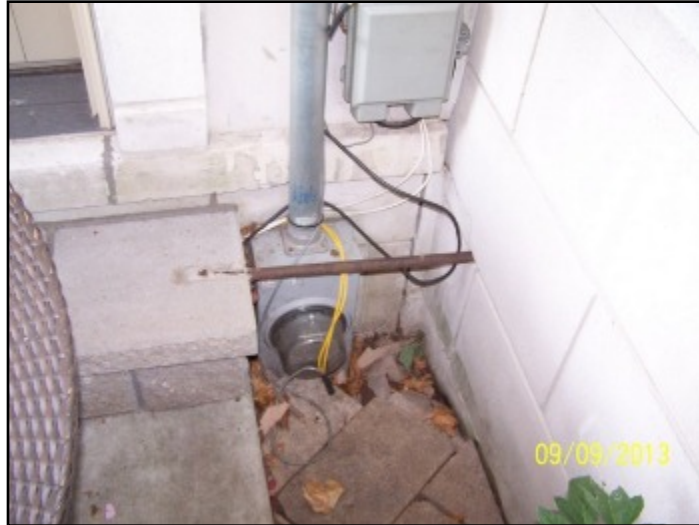
Meter socket is at grade. ComEd requires 30" minimum clearance from grade to meter base (ComEd Residential Electric Service Installation Guide, 5th Edition, page 28). Have meter base height corrected by licensed electrician per ComEd requirements prior to closing.

*Improper meter location*

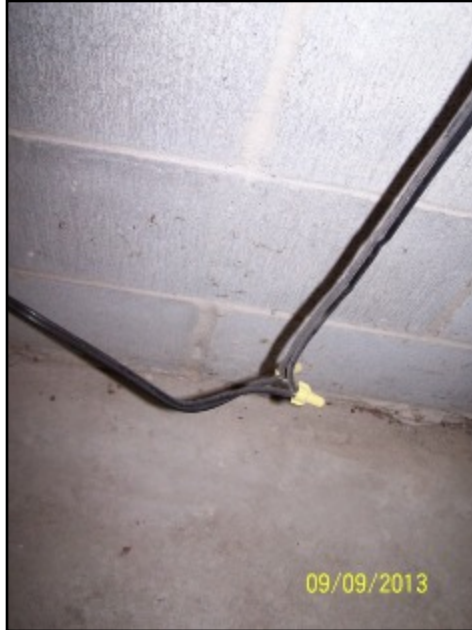
Exposed splices in garage. Have wire properly enclosed by licensed electrician prior to closing.

*Exposed wire splice at garage*

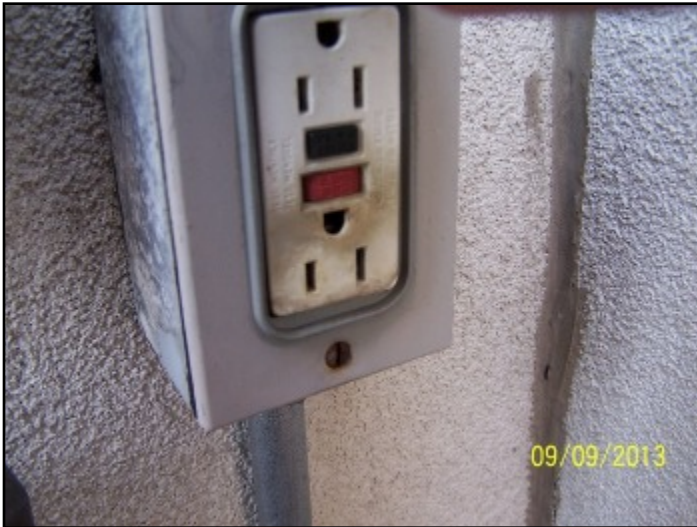
**Condition:** • [GFI test faulty](#)

*Scorch marks on faulty GFI*

**Task:** Replace Faulty GFCI

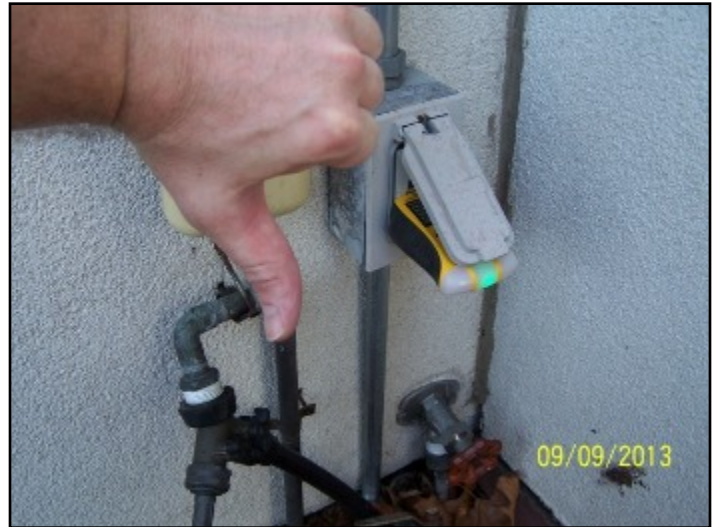
*GFI test faulty*

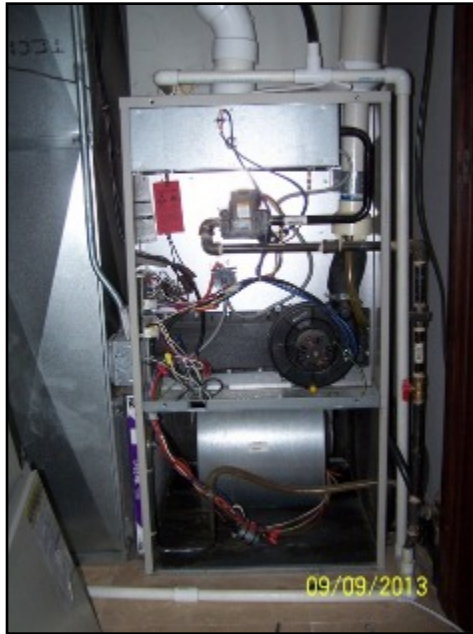
**Condition:** • Clean, Check And Service.

*Clean, Check, and Service Annually*

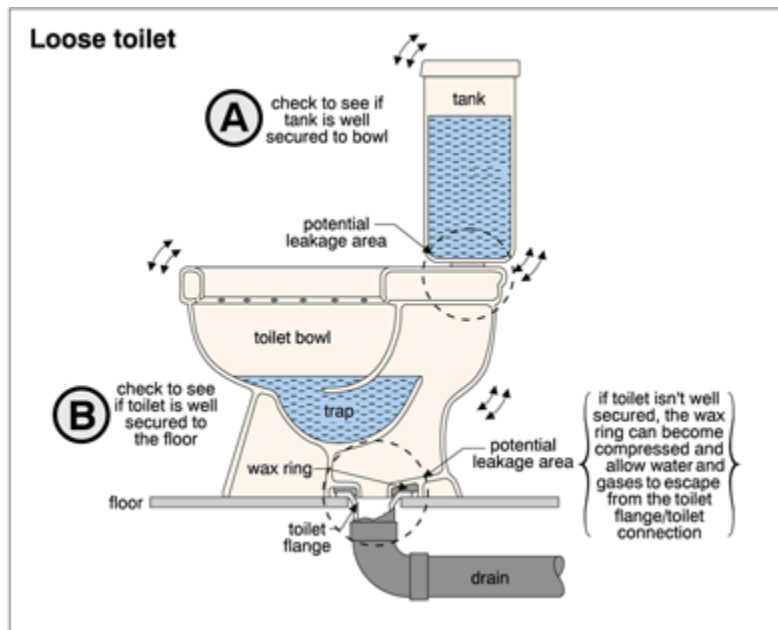
Loose toilets. Have licensed and insured plumbing contractor replace wax ring and re-seat loose toilet prior to closing.

**Task:** Repair

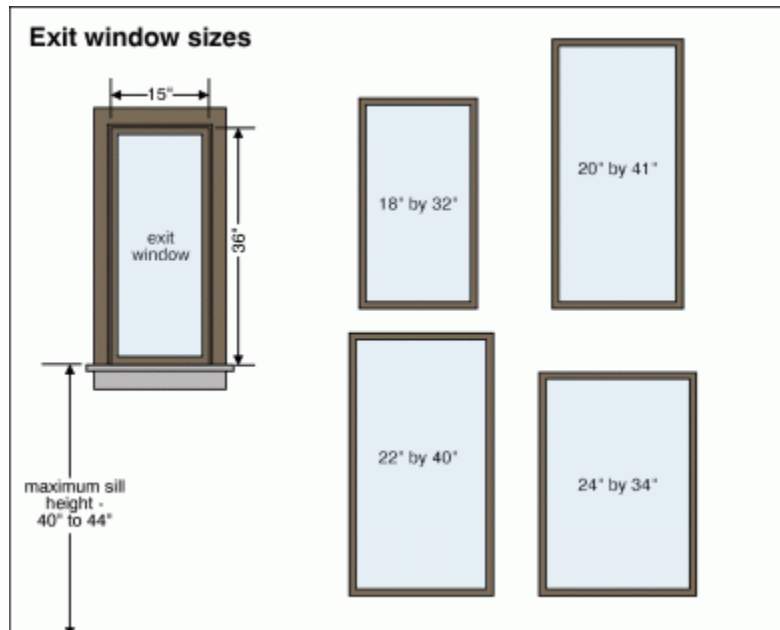
Basement bedrooms: Windows too high from finished floor surface to conform to current national standards for emergency rescue openings.

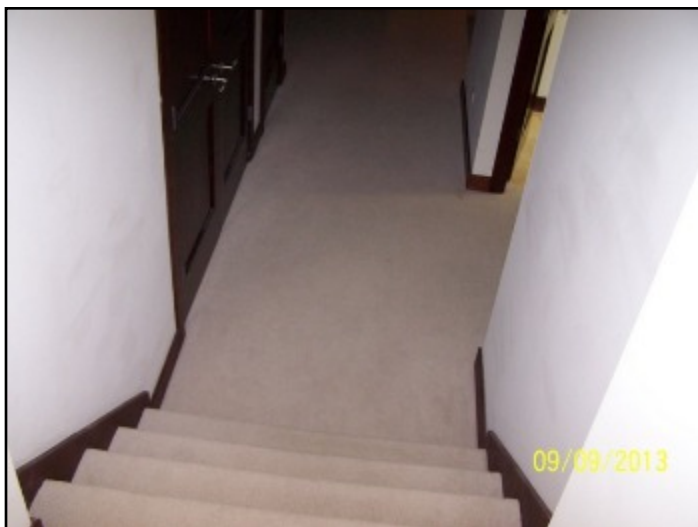
Fall hazard: missing handrails

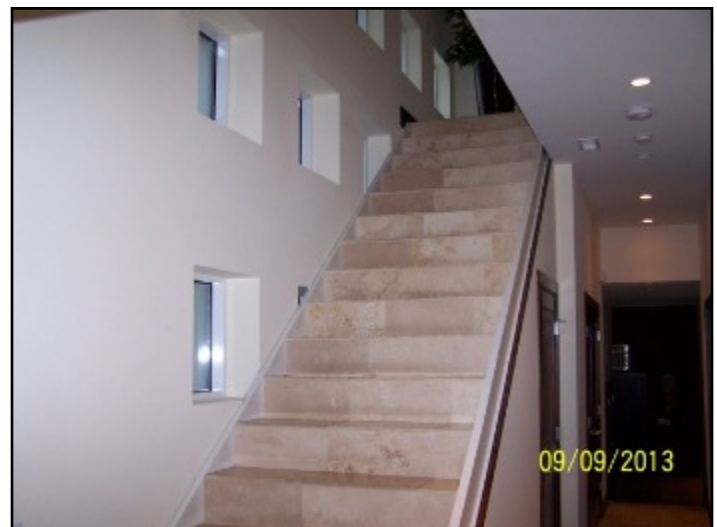
Missing hand- and guard-rails
