INSPECTION REPORT

For the Property at:
300 W. WISCONSIN , #1A
CHICAGO, IL 60614

Prepared for: SUSAN SMITH
Inspection Date: Friday, April 19, 2013
Prepared by: Thomas Jansson

RE: Report No. 1360, v.4
300 W. Wisconsin , #1A
Chicago, IL
60614

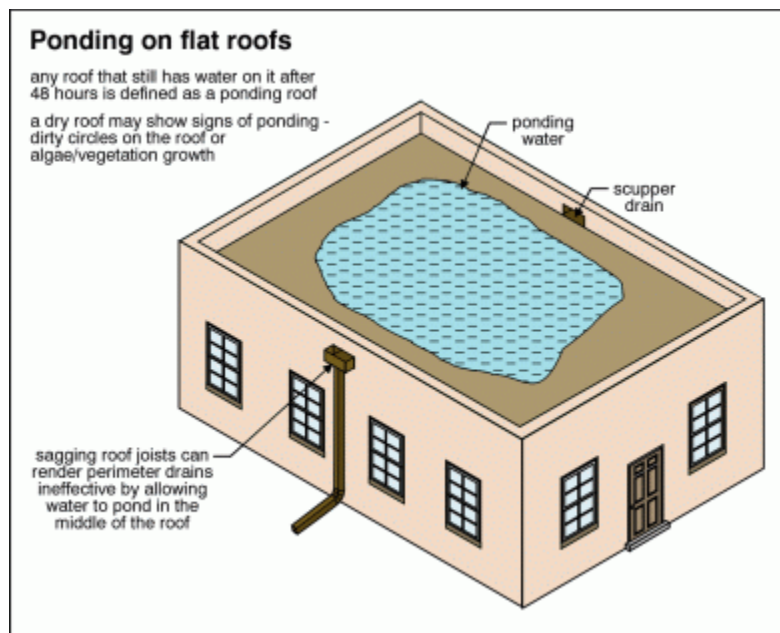
Condition: • [Ponding](#)

Clogged roof drain. Have cleared by licensed plumber at earliest opportunity. See notes in "Exterior."

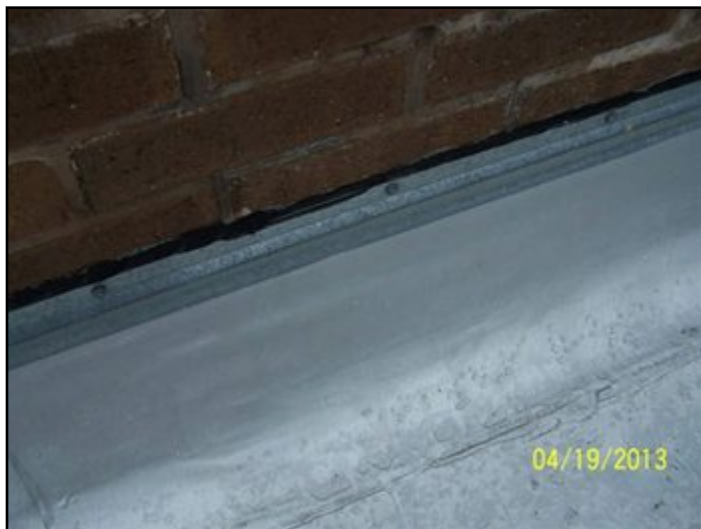
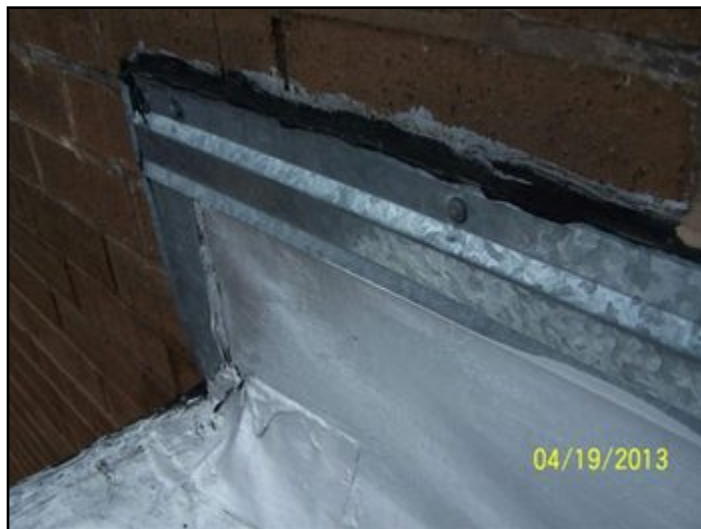
Condition: • [Counter flashings not let into masonry](#)

Counter flashings not let into masonry

This is the new industry standard for flashing. Regular maintenance is required to prevent roof leaks. Have roof inspected and "tuned up" annually by licensed roofing contractor.

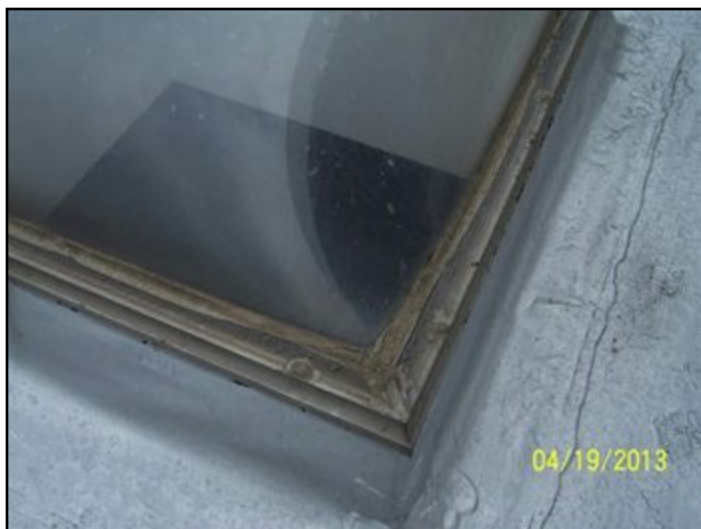
Condition: • Previous repair noted at skylights. No leaks were observed at inspection. Monitor and service as needed during annual roofing tune-up.

Previous repair to skylights

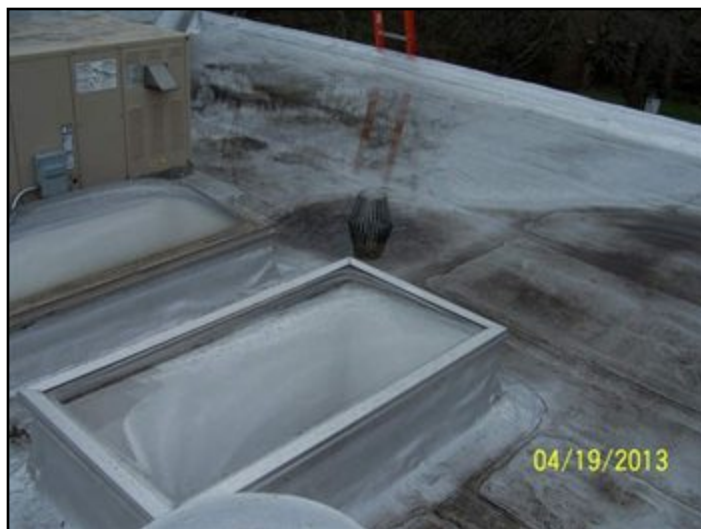
Ponding on roof due to clogged drain

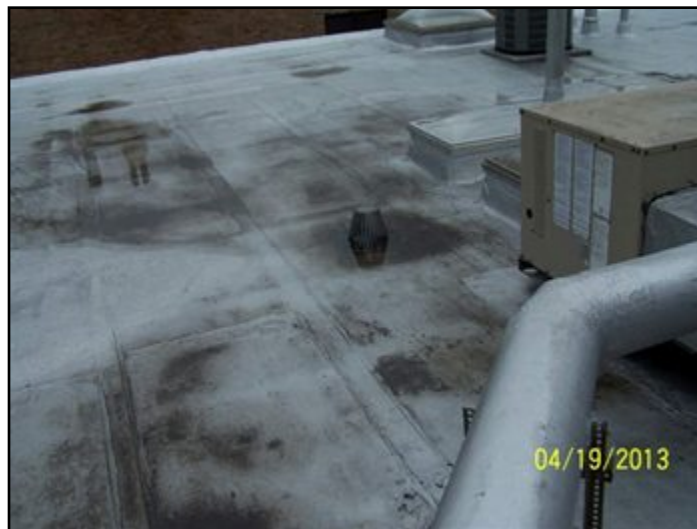
Ponding, standing water on roof due to clogged roof drain. Seller states that this is a recurring problem at roof. This is somewhat unusual. While the exact cause and location of the blockage cannot be determined by a home inspection, it may be possible that the obstruction is beyond the reach of a portable snake. High roof with poor access; contractors may need to use a lift in order to move appropriate drain cleaning equipment into position.

interior flat roof drains clogged with debris can cause water ponding, leading to: shortened roof life, possible freeze/thaw damage, additional weight/roof sag and significant water infiltration if a leak occurs

Clogged roof drain

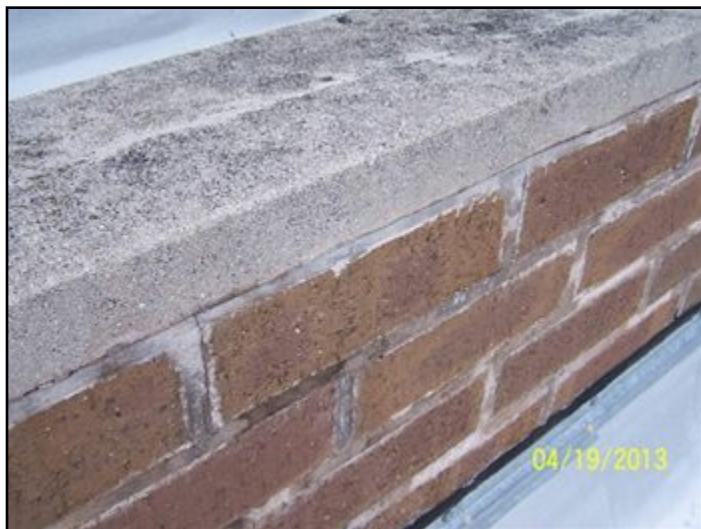
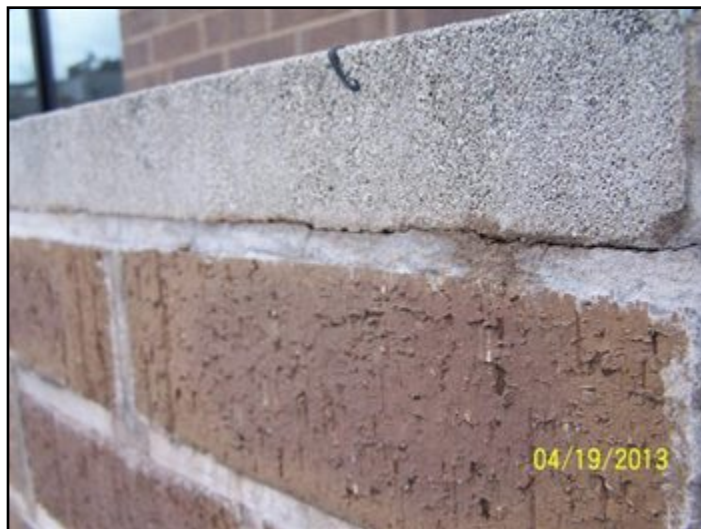
No flashing beneath parapet cap, east. Lack of flashing at this point can sometimes lead to water entry at top of parapet wall. No leaks observed at inspection. Parapet should be closely monitored for changes and leakage. Have checked annually by licensed roofing contractor during regular roof maintenance.

Flashings missing at parapet cap

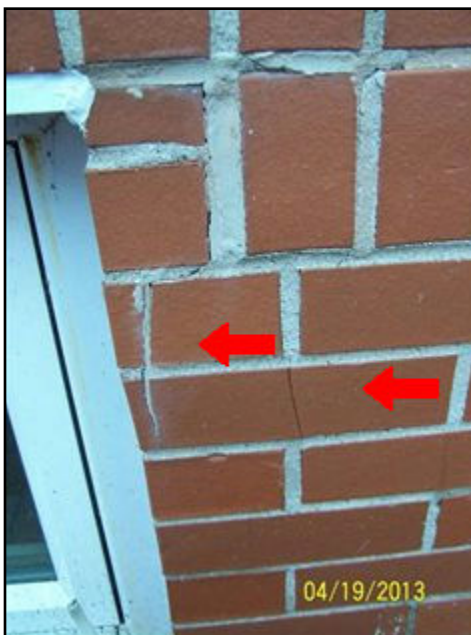
Cracked brick at front, ground level. Have damaged brick repaired as needed by licensed masonry contractor prior to closing.

Cracked Brick

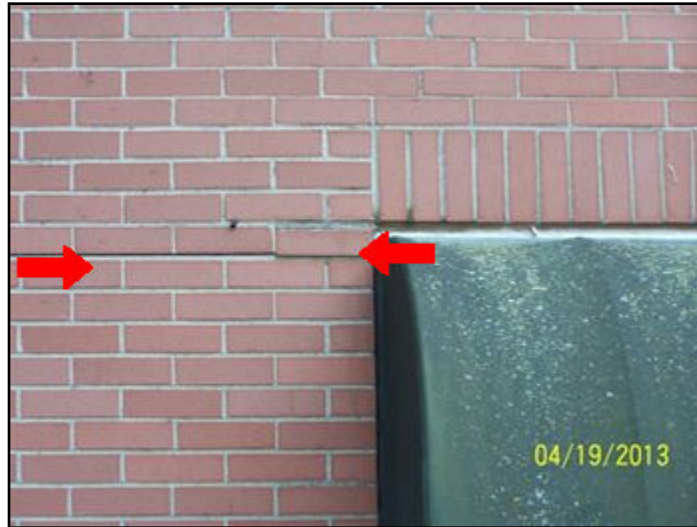
Mortar deterioration appears to be related to rusting lintels. Have mortar repaired as needed prior to closing.

Mortar deterioration

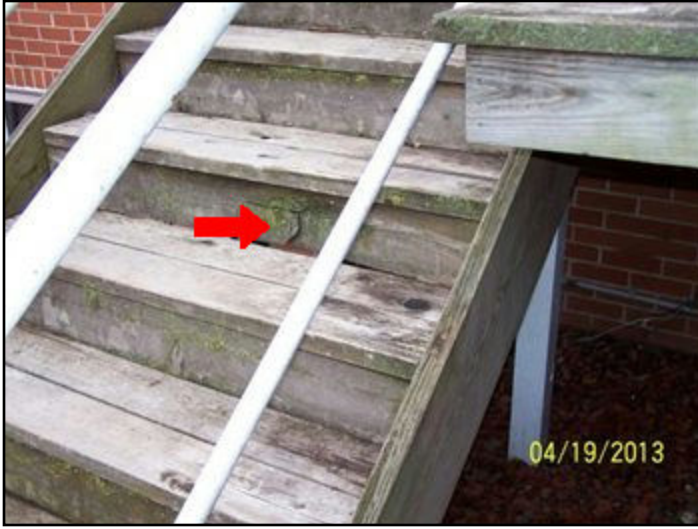
Condition: • Front steps and porch are in hazardous condition and should be replaced immediately by licensed and insured contractor. Noted defects include: Missing guard rail, missing post, improper support, improper hand rail, damaged stair riser, wood/soil contact, and general disrepair.

Damaged riser, improper handrail

Have front steps and porch replaced by licensed and insured contractor prior to closing.

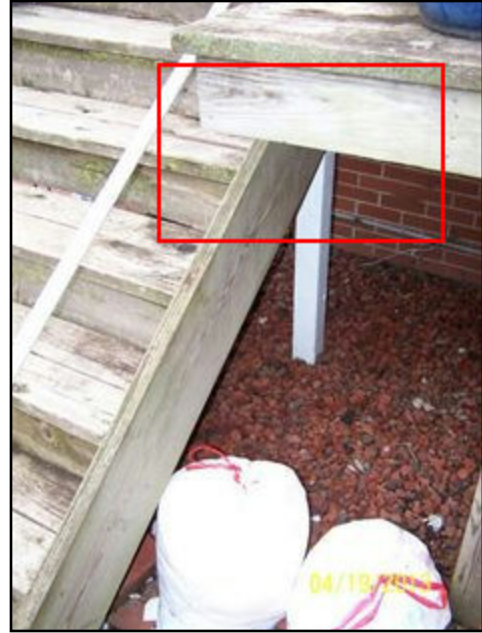
Porch lacks support post

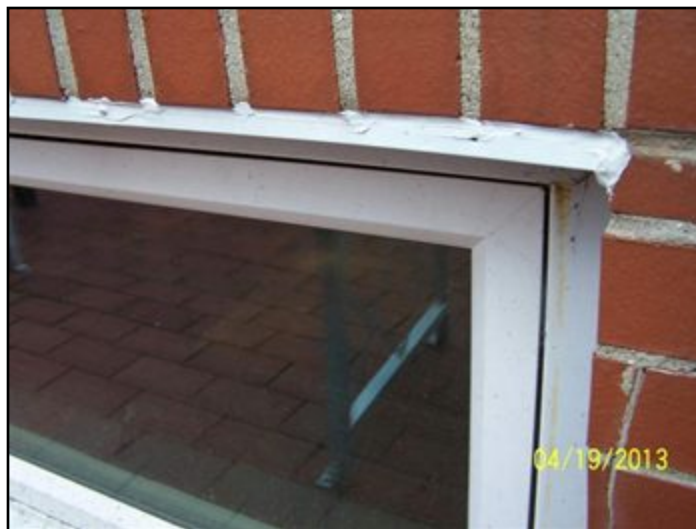
Condition: • Space above lintel has been filled with caulk. This space should be left open. It is supposed to provide drainage for the wall cavity. Caulking the lintel can contribute to interior water problems, and will contribute to rust and premature failure of the lintel.

Space above lintel has been caulked

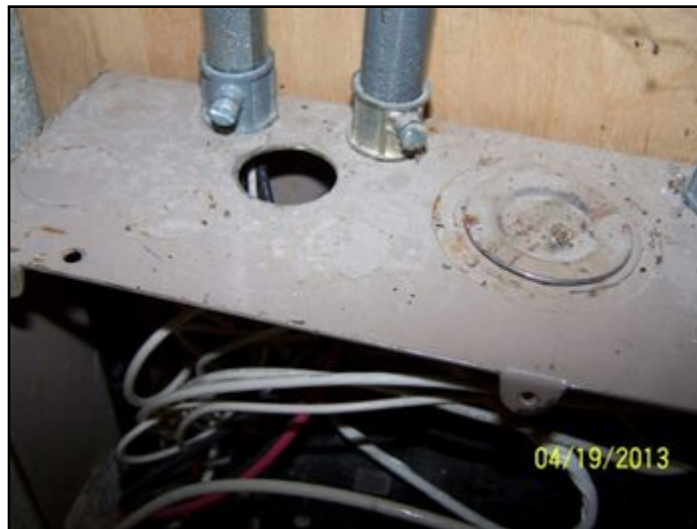
Panel crowded. Mini breakers present. Numerous double-lugged breakers indicate that this panel may be beyond its capacity and should be replaced. Additional defects include abandoned wire in panel, openings in panel, loose dead front. Have panel replaced by licensed electrician prior to closing.

Condition: • [Openings in panel](#)

Openings in panel

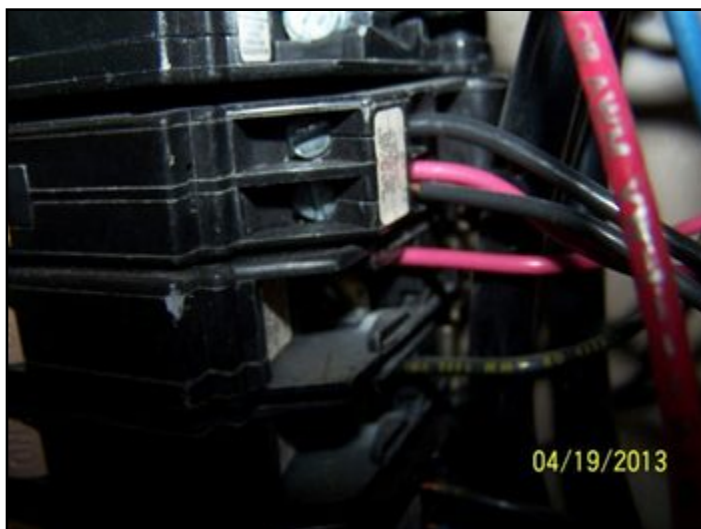
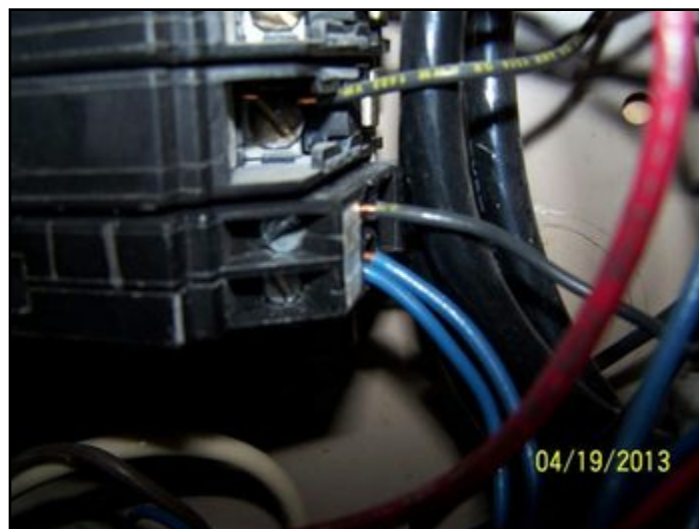
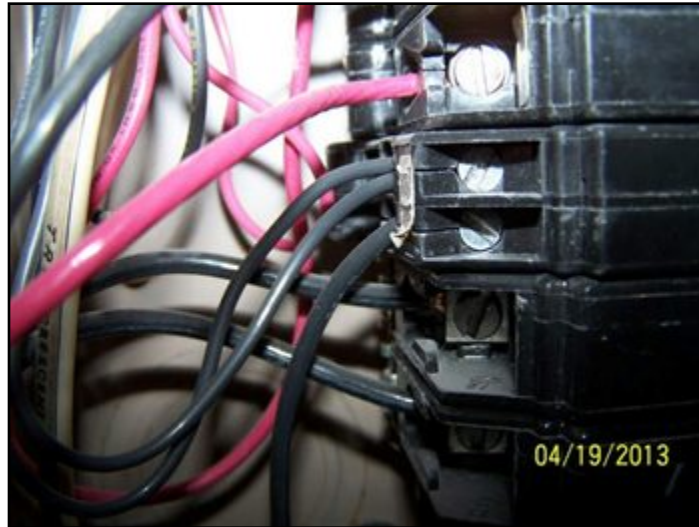
Condition: • [Double taps](#)

*Double tap*

*Double taps on a mini-breaker*

Double taps on a mini-breaker

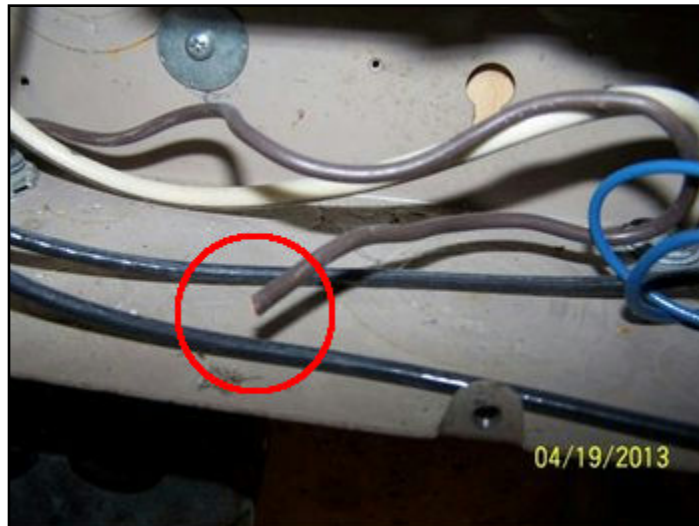
Condition: • [Abandoned wires in panel](#)

Abandoned wire in panel

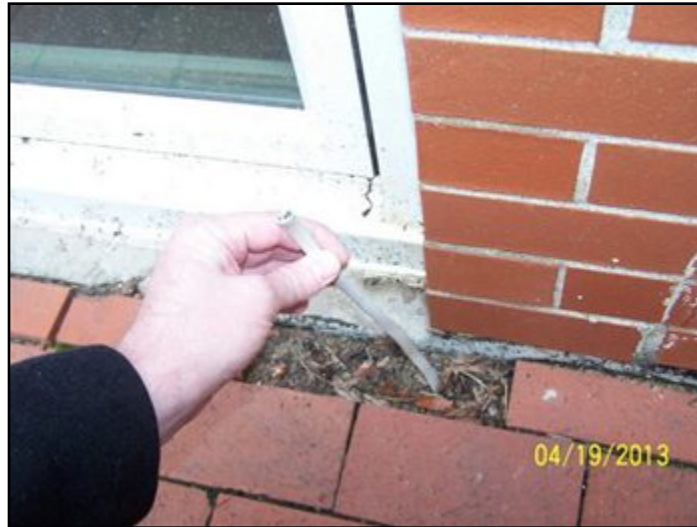
Condition: • [Abandoned wire](#)

Abandoned wire

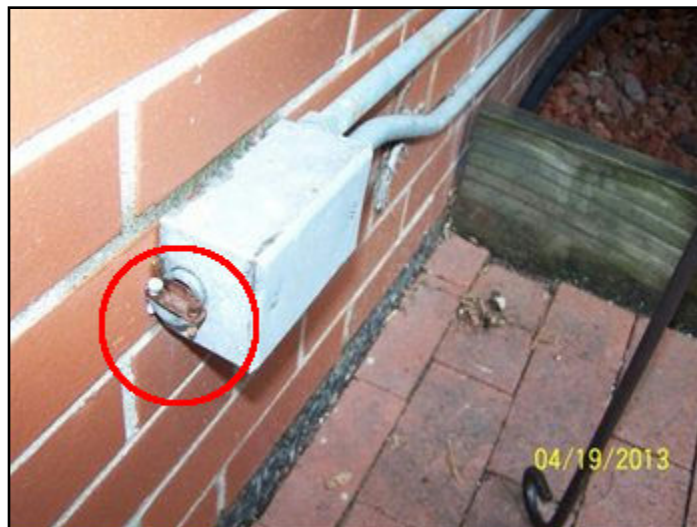
Condition: • Not Watertight

Not Watertight

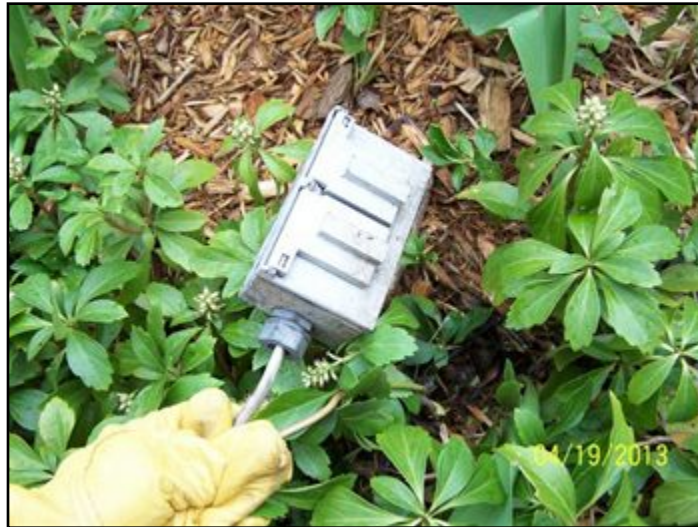
Condition: • [Buried wire](#)

Missing conduit

Buried wire, no conduit

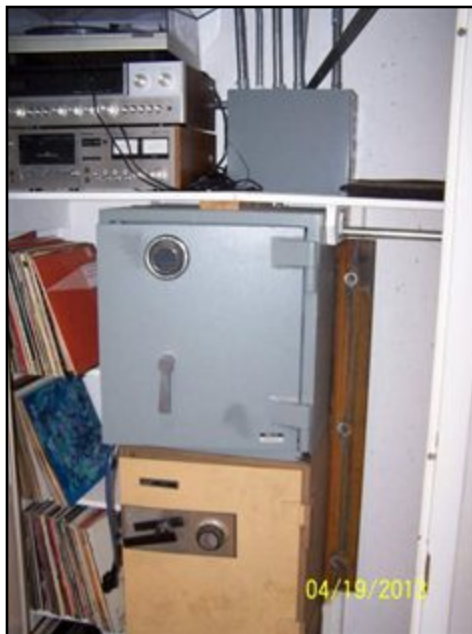
Major pull-box in basement is blocked with large safe welded and bolted to foundation. Junction boxes should not be concealed or blocked. Have safe removed or relocated prior to occupancy.

Concealed/blocked electrical boxes

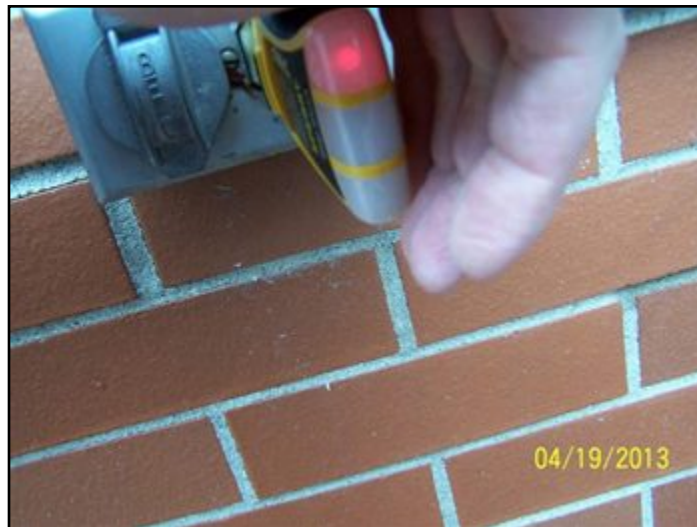
Condition: • [Ground needed for 3-slot outlet](#)

Ground needed for 3-slot outlet

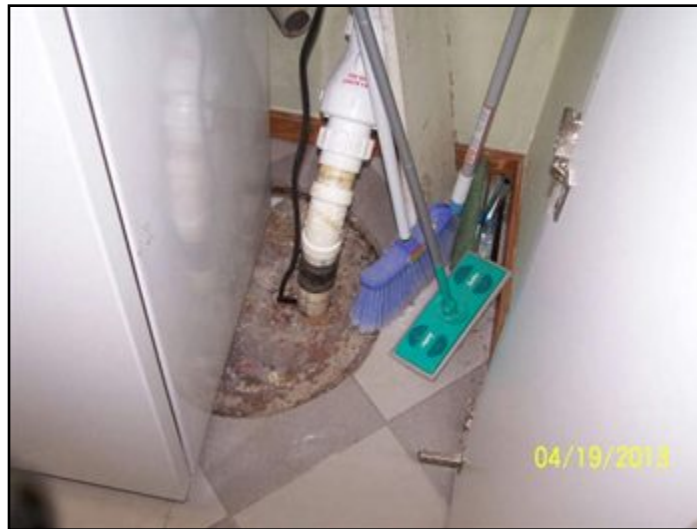
Condition: • Poor access

Poor access to ejector pump

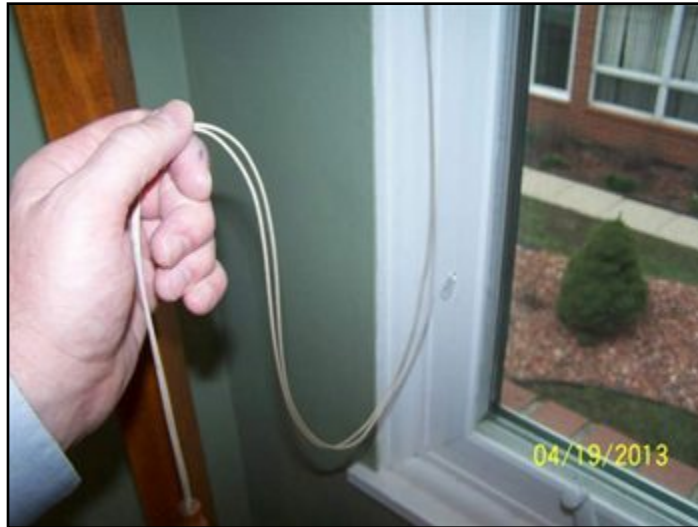
Condition: • The U.S. Consumer Product Safety Commission (CPSC) is announcing that multiple firms are recalling millions of units of Window coverings, including Roman shades and roll-up blinds. These window coverings present a serious risk of strangulation to young children.

Loose blind cords throughout

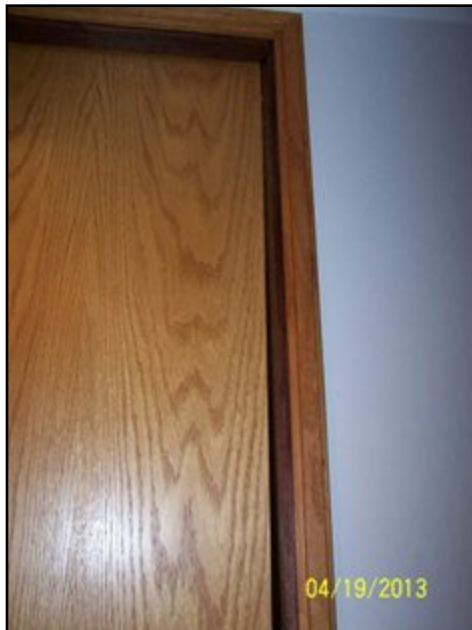
Poor fit. Pocket doors throughout second floor are not square to opening. Cannot be fully closed or latched. Repair/Replace as desired.

Loose or poor fit at pocket doors

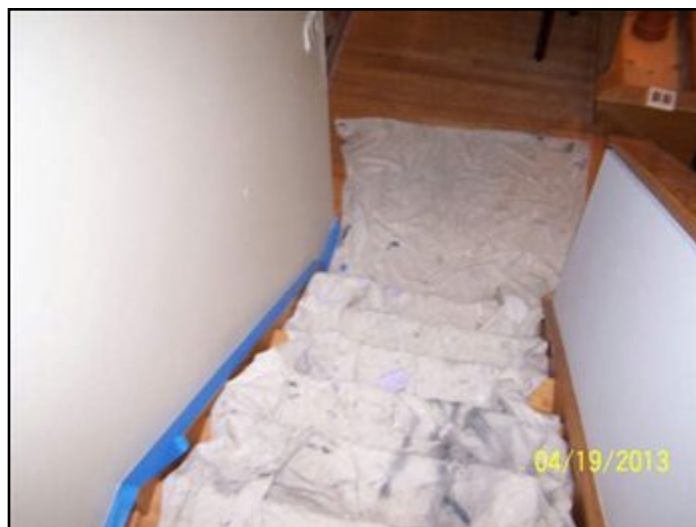
Graspable handrails missing throughout. Install as needed.

Missing handrails throughout
