# INSPECTION REPORT

For the Property at:  
**3700 S. CENTRAL**  
CICERO, IL 60804

Prepared for: JANE DOE  
Inspection Date: Thursday, October 17, 2013  
Prepared by: Thomas Jansson

RE: Report No. 1398, v.2  
3700 S. Central  
Cicero, IL  
60804

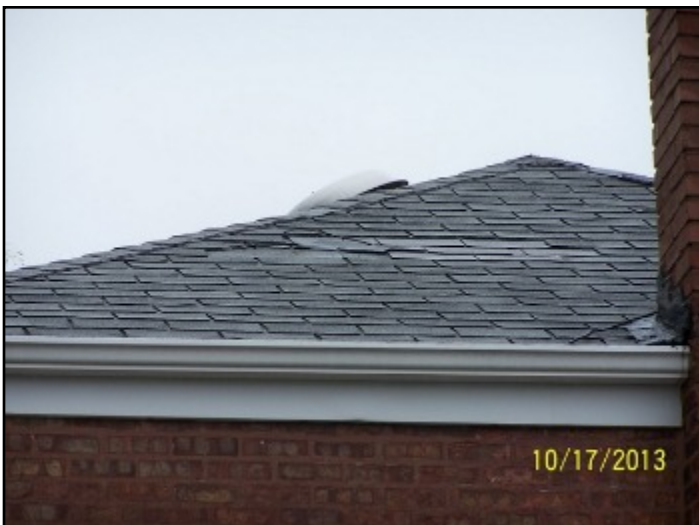
Shingles are showing signs of advanced age and wear. Damage and deterioration noted throughout roof.

Exposed sheathing at south; chance of water entry, chance of rot. Some plank sheathing replacement may be necessary when replacing roof.

*Missing shingles*

Roofing replacement is recommended at this time.

Obtain roof replacement estimates from qualified roofers prior to closing.

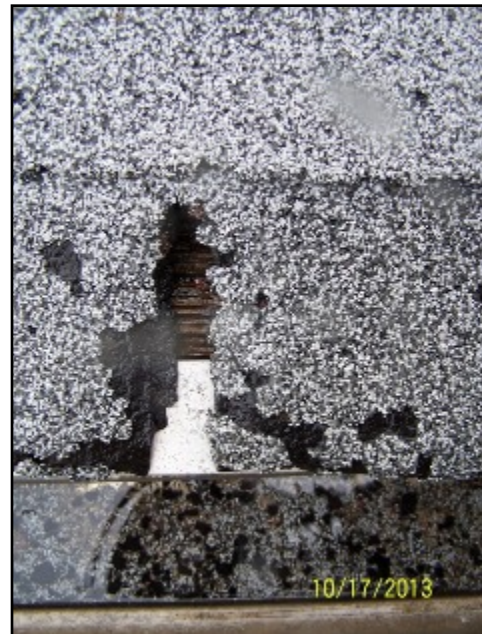
*Exposed sheathing*

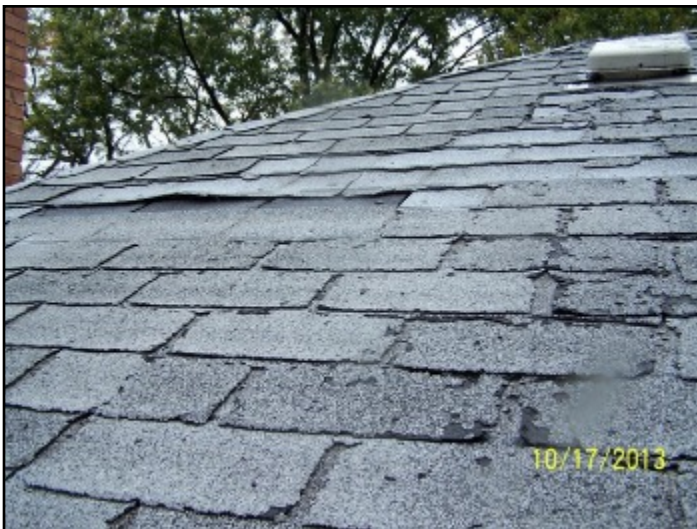
*Missing, loose or torn*

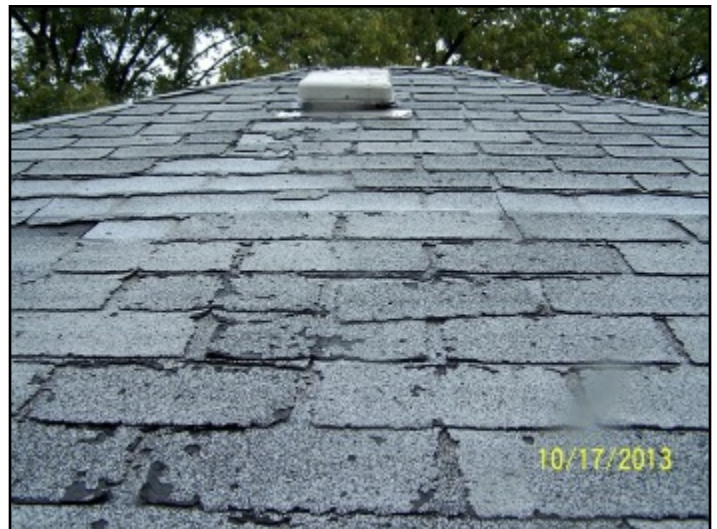
*Roof is in poor condition*

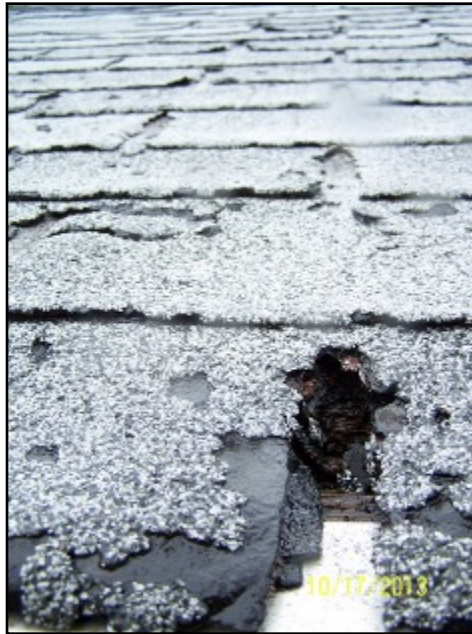
*Exposed sheathing*

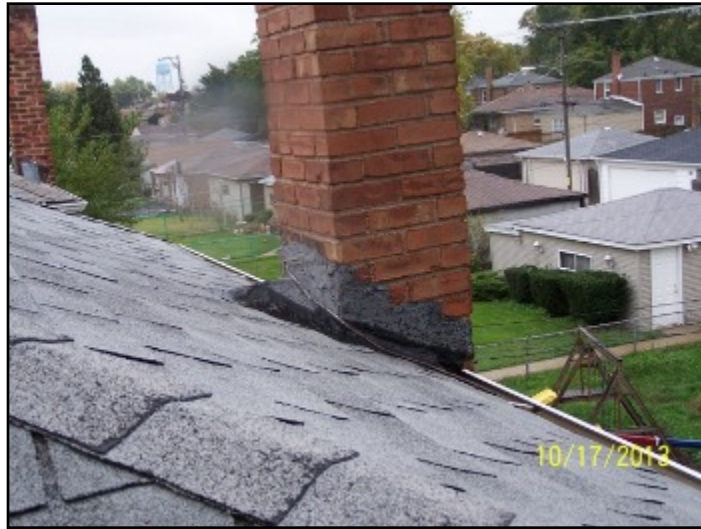
Chimney is "flashed" with tar. Although common, tar "flashing" is a problematic solution to roof leaks. This is a low-cost alternative to real chimney flashing. May leak unexpectedly; regular maintenance is needed to prevent roof leaks. You are encouraged to have the chimney properly flashed with metal flashing when replacing roof. Consult with licensed roofing contractor for repair estimates.

*Chimney "flashed" with roofing cement*

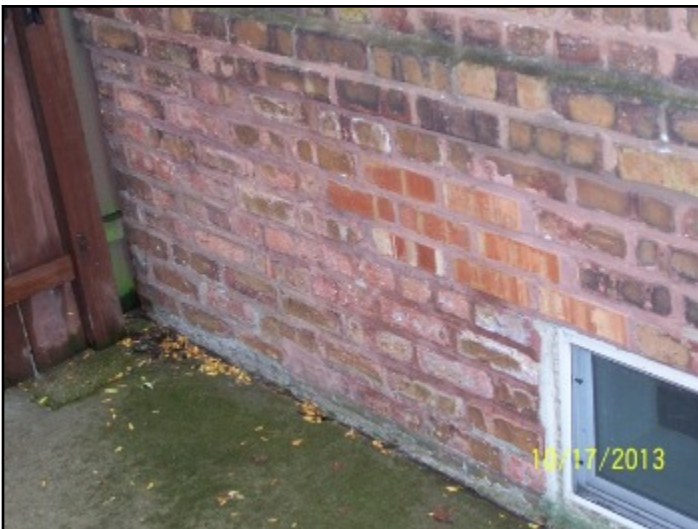
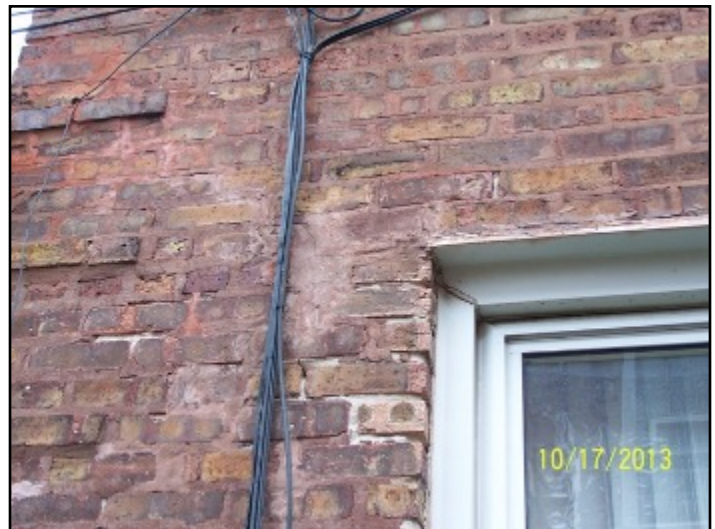
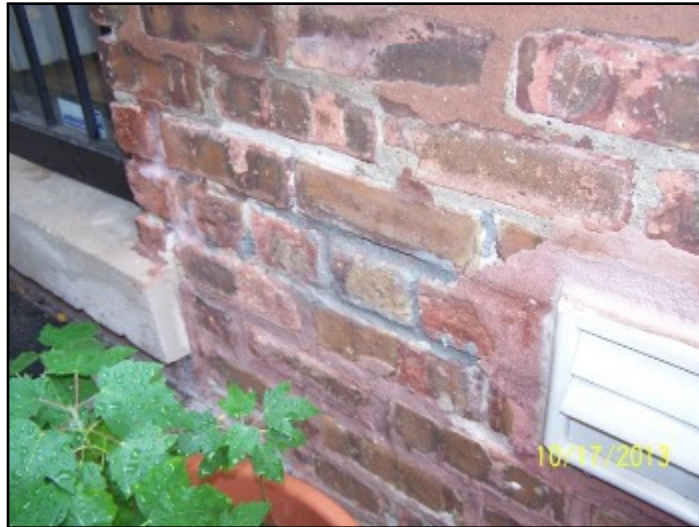
Masonry deterioration; brick erosion/spalling noted at south, southwest, and north. Typical defect for buildings of this age and type. Mortar repair and brick maintenance is needed throughout. Consult with licensed masonry contractor for whole-house tuck-pointing quote prior to closing.

Masonry deterioration

*Masonry deterioration*

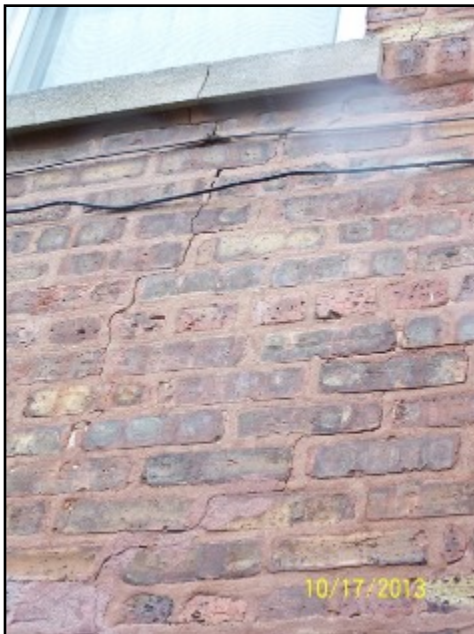
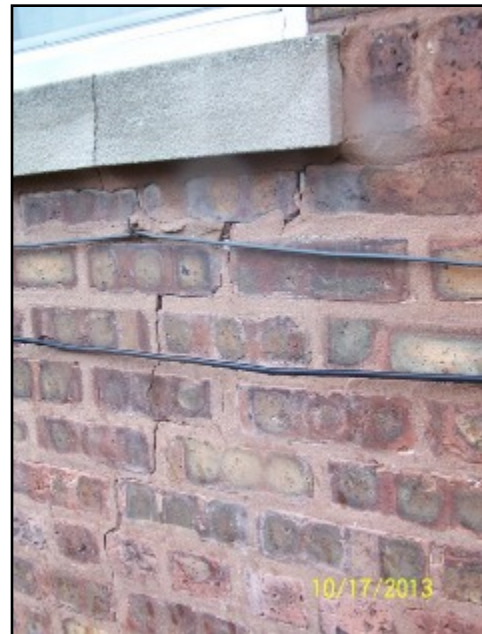
Mortar cracks noted throughout. Structural movement suspected. Have mortar repaired by licensed masonry contractor as needed throughout prior to closing.

*Mortar deterioration*

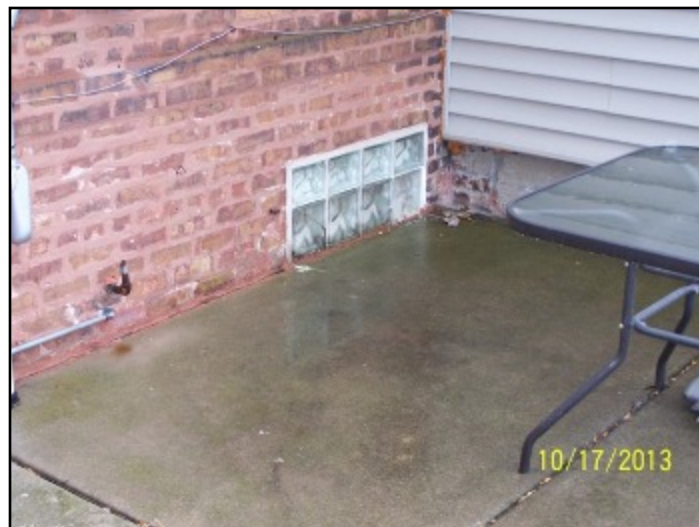
**Condition:** • Glass block below grade. May contribute to water entry in basement. Cracked block. Replacement of glass block with solid brick is recommended. Have evaluated and repaired as needed by licensed masonry contractor.

*Window below grade; chance of water entry*

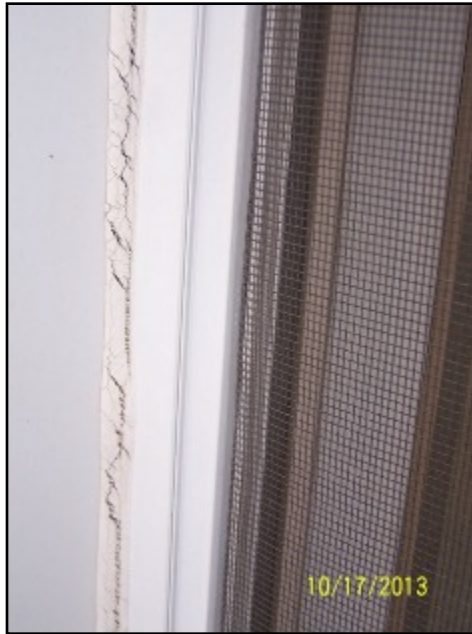
*Deteriorating caulk at windows throughout*

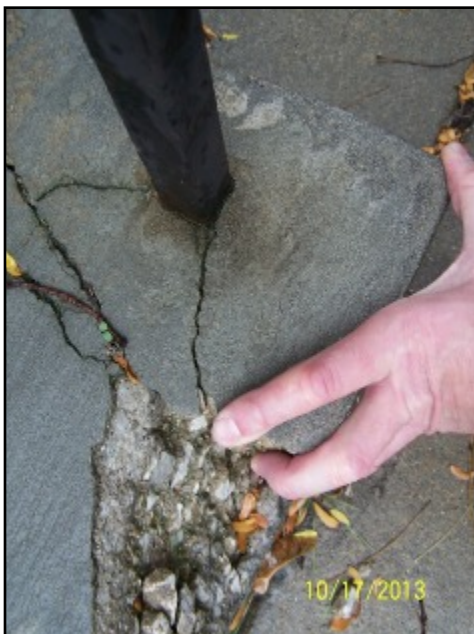
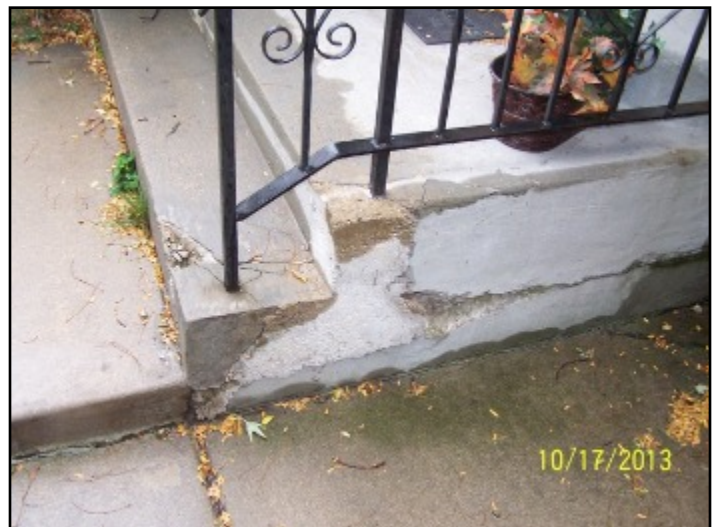
Previous cosmetic repairs. Front steps are cracking. Loose concrete, loose handrail. Have steps replaced by licensed masonry contractor prior to closing.

*Loose materials*

*Masonry or concrete cracking*

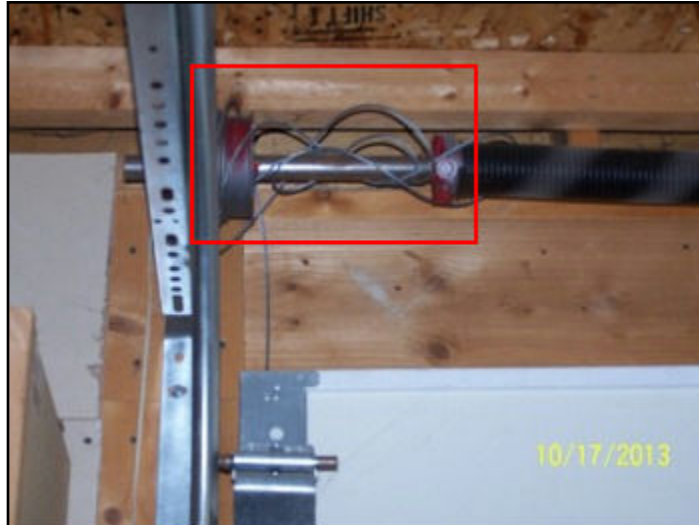
Yard-side vehicle door failed to close due to tangled cable. Have repaired as needed by licensed garage door repairman prior to closing.

*Tangled cable*

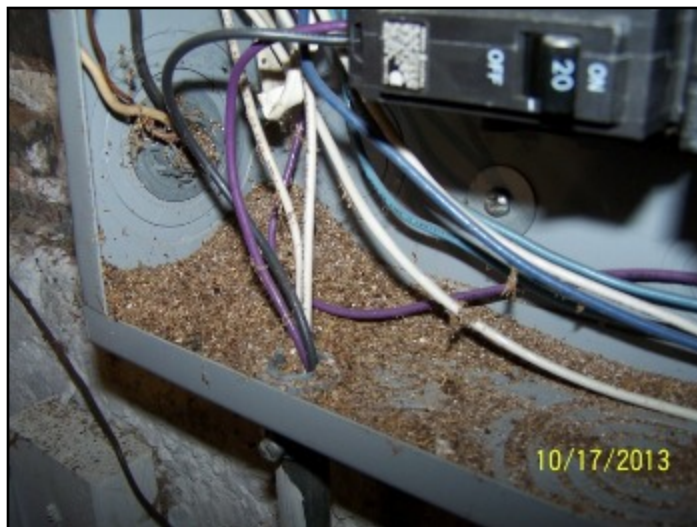
- Possible insect activity noted at NE corner of building at basement. Unidentified "sawdust-like" material was observed in electrical panel. This material may be related to insect activity. Further evaluation by a licensed pest contractor specializing in wood-destroying organisms is recommended prior to closing.

*Unidentified debris in electrical panel.*

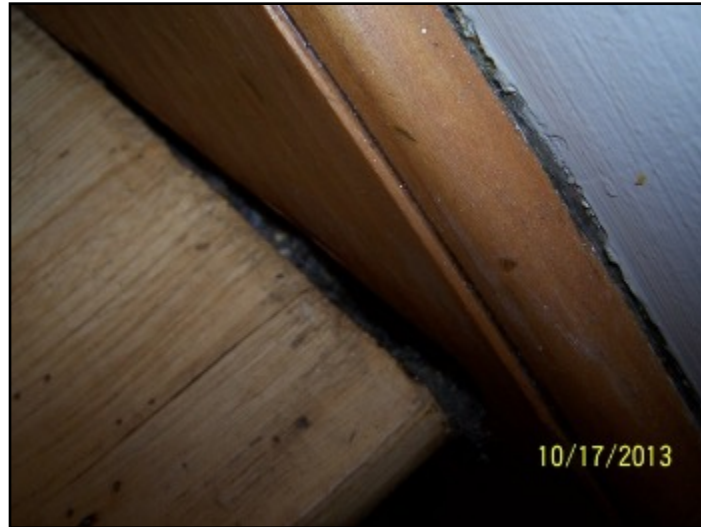
- Main stairway is pulling away from trim stringer at north. It appears that the top of the stairway has moved approximately 1-1/2" laterally away from the wall. Further review and repair as needed by licensed structural contractor is recommended prior to closing.

*Lateral movement at stairway*

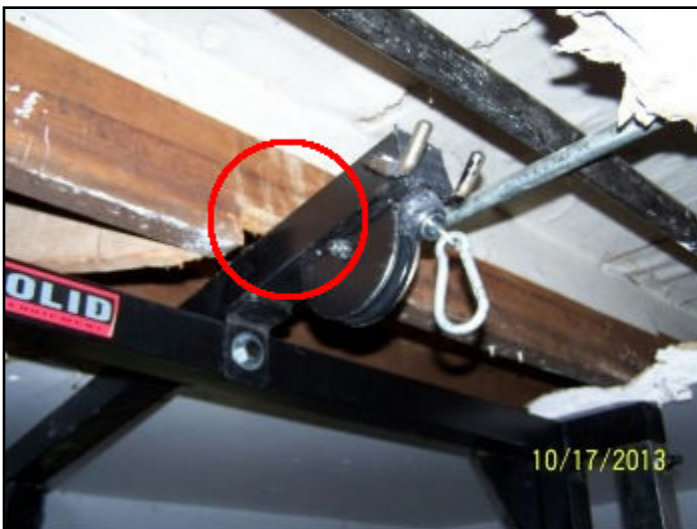
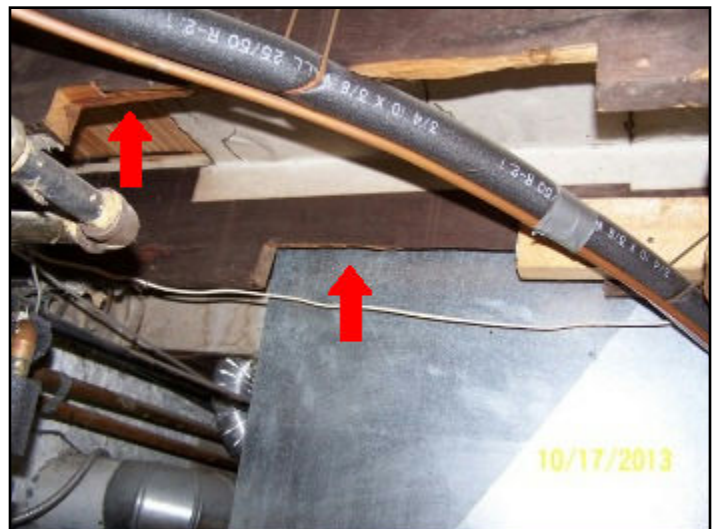
Notches or holes

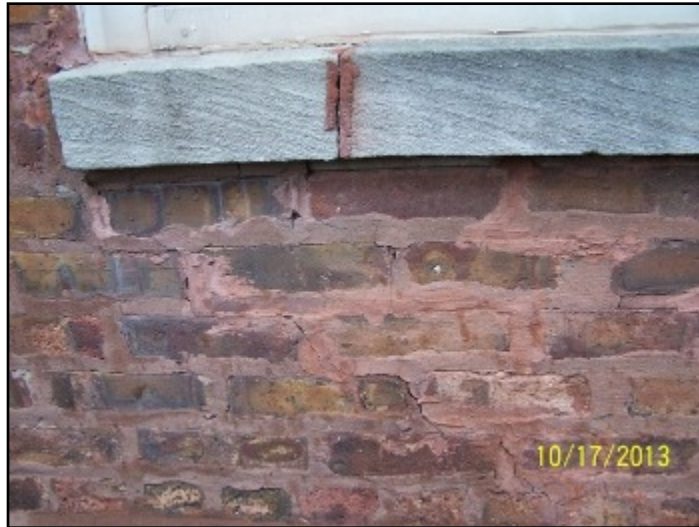
Cracked window sills indicate structural movement. Have repaired or replaced as needed by licensed masonry contractor prior to closing.

*Cracked sill*

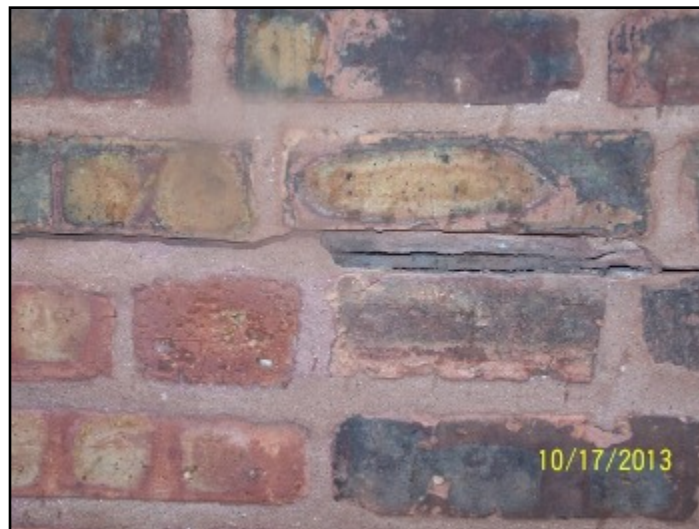
Have lintels serviced as needed when tuck-pointing exterior of structure. It appears that a window was removed and bricked up at the north. The lintel was left in the wall, and is now deteriorating and pushing the bricks apart. Have repaired as needed by licensed masonry contractor.

*Lintels rusting*

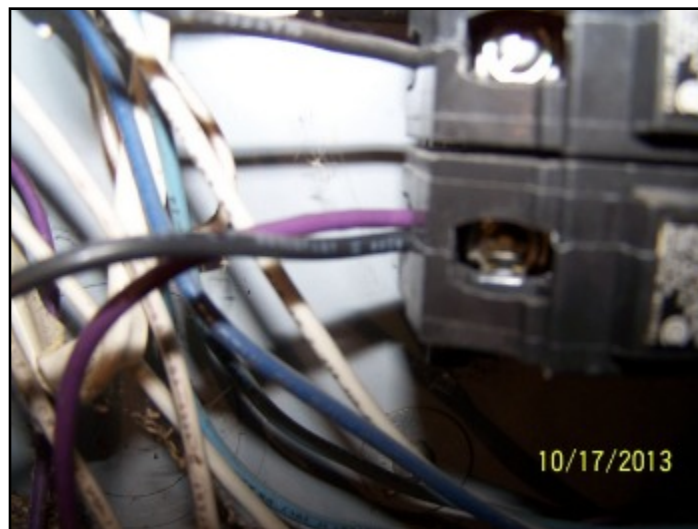
**Condition:** • [Double taps](#)

*Double taps*

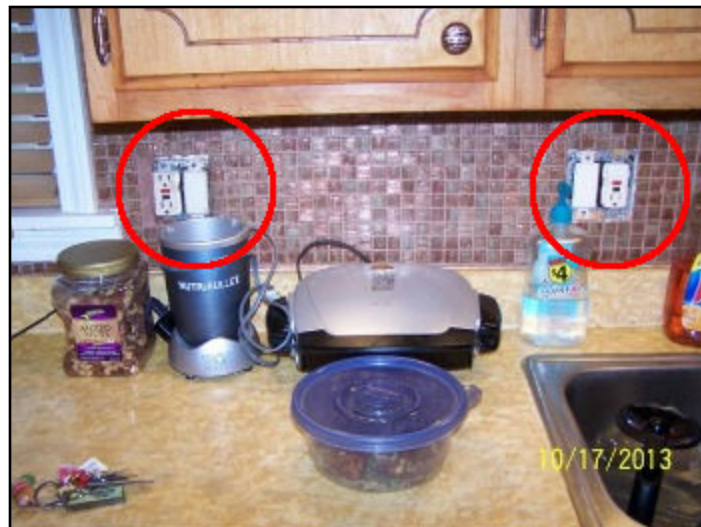
*Missing cover plates*

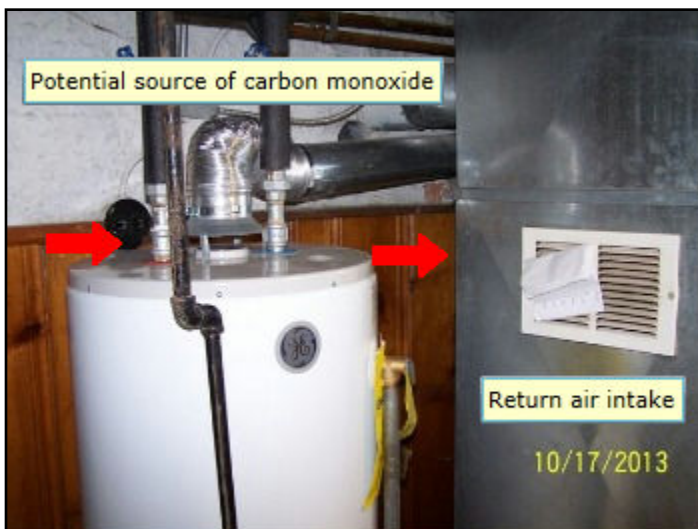
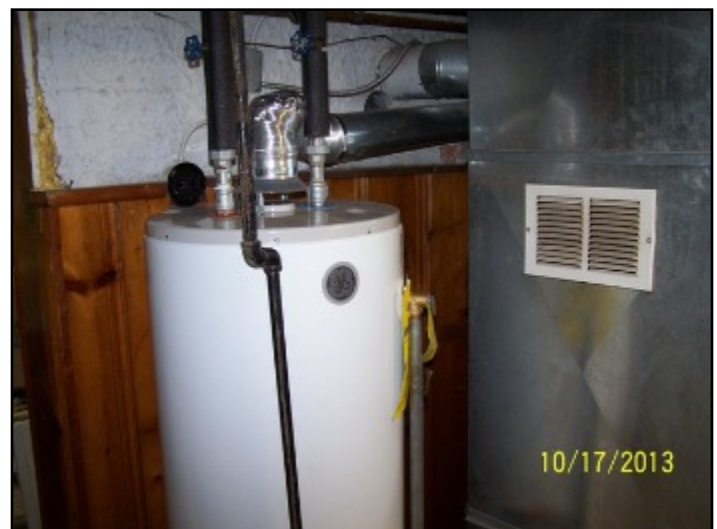
*Paper indicates this is return (suction) duct*

*Openings in return duct are hazardous here*

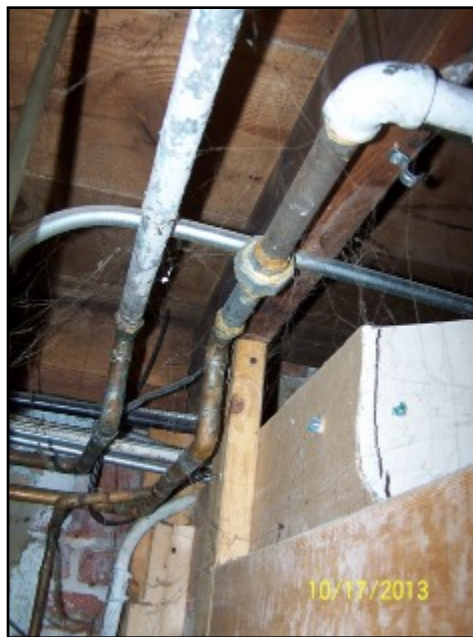
Supply piping is a mix of newer copper and older galvanized steel. The galvanized has a service life of 50 years. After that time, problems can develop, including leakage and reduced water pressure. Replacement of the remaining steel supply pipe is recommended as a preventative measure. Timing is discretionary, but should probably be done within the next 5-10 years.

*Galvanized steel and copper supply pipe*

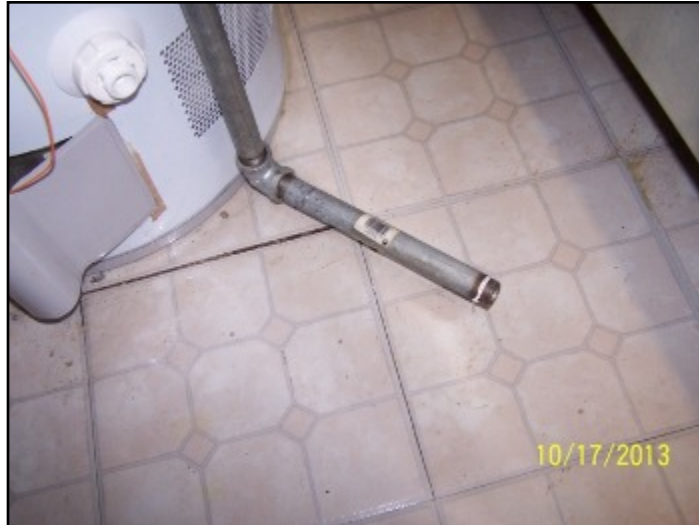
*Discharge tube threaded, not straight*

Have water heater TPR discharge tube replaced in accordance with manufacturer's instructions by licensed and insured plumbing contractor prior to closing. A straight copper tube of the proper diameter and length is preferred.

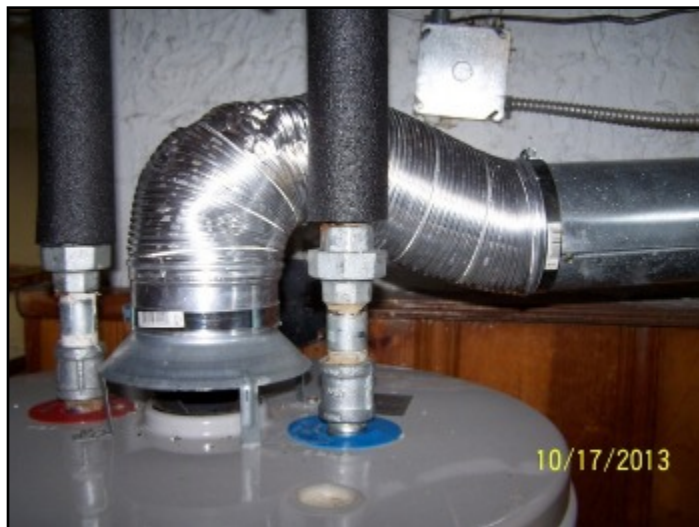
Flexible ductwork used as vent connector. Improper slope; may cause backdrafting of combustion gasses into house. Have reviewed by licensed plumbing or heating contractor and repair as needed.

*Improper material/poor support*

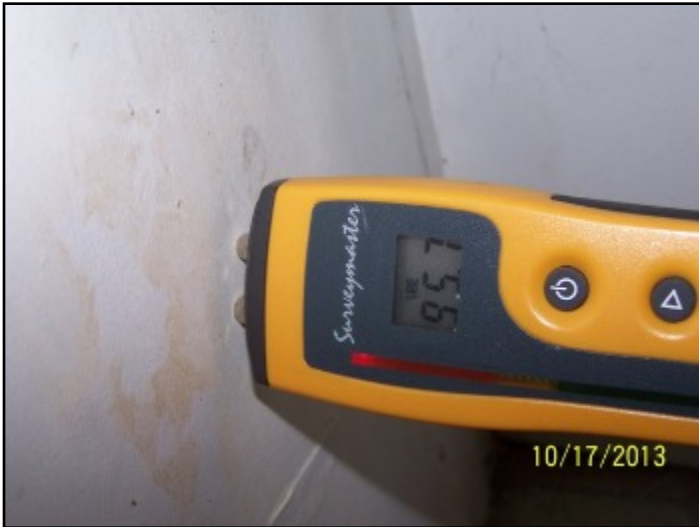
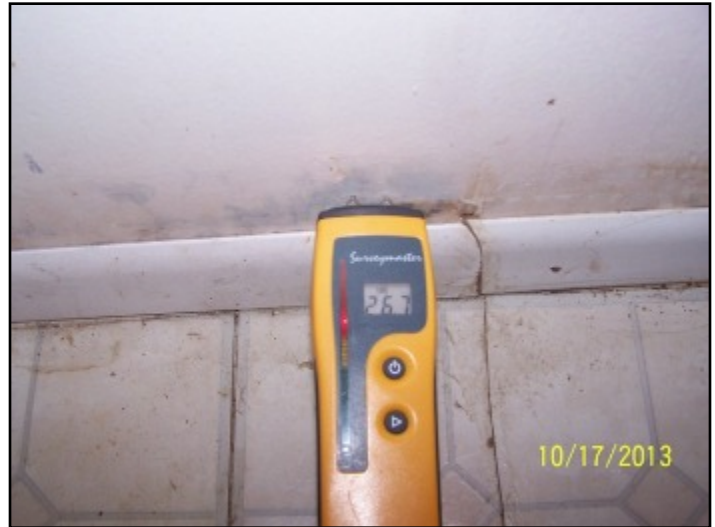
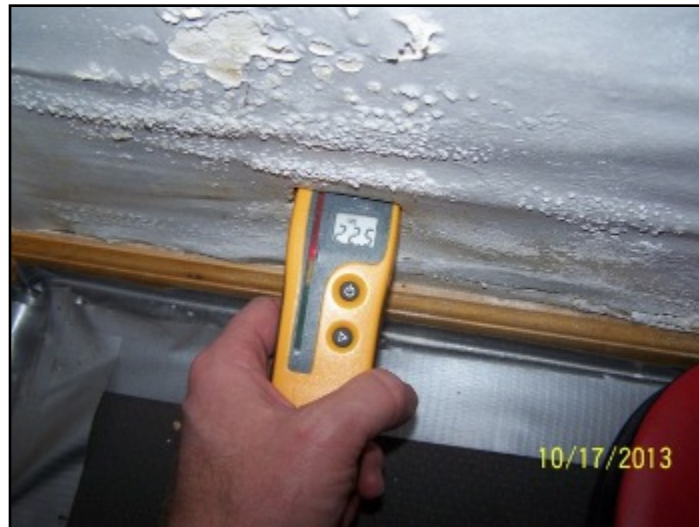
Very high moisture levels noted at basement interior at south and east. Advanced rot and deterioration observed at weight room (south side near front of building). Mold or mildew staining observed at south and east.

Extremely high moisture levels were observed; it is almost a certainty that rot and mold will be found once the drywall has been removed.

*Moisture saturation, basement south*

*Water damage, elevated moisture, basement eas*

*Water damage, high moisture levels, basement*

Drywall should be removed as needed throughout basement, to facilitate further investigation and repair. Foundation cracks are probably present, but could not be directly observed due to the presence of drywall. Have basement leaks repaired by licensed basement waterproofing contractor prior to closing.

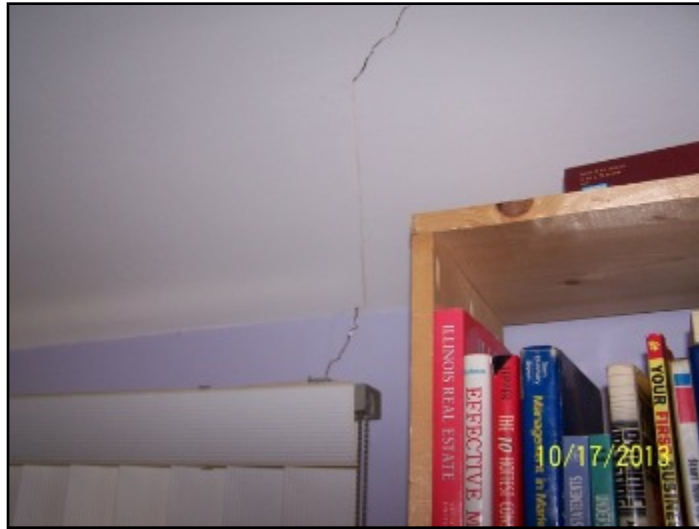
*Cracked wall*

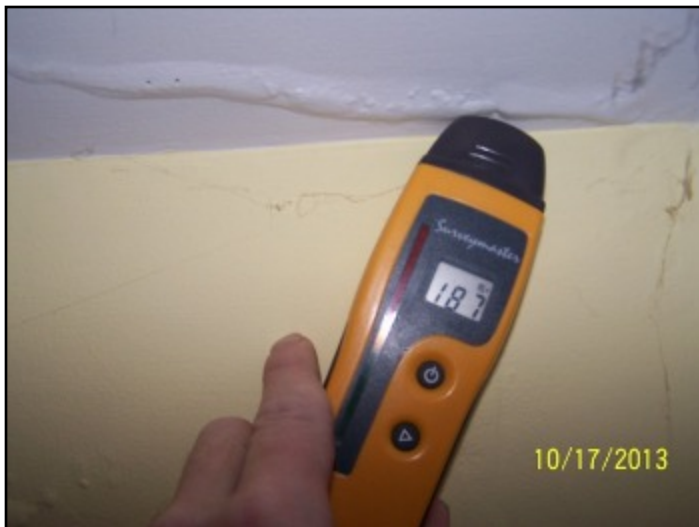
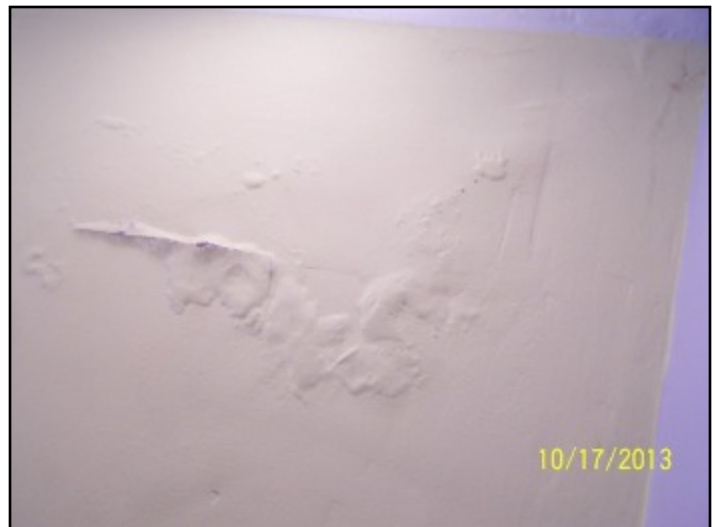
Elevated moisture levels may support mold growth. Mold testing was not performed at this inspection.

*Elevated moisture readings (18%)*

*Water damage*
