# INSPECTION REPORT

For the Property at:  
**3700 S. CENTRAL**  
CICERO, IL 60804

Prepared for: JANE DOE  
Inspection Date: Thursday, October 17, 2013  
Prepared by: Thomas Jansson

RE: Report No. 1398, v.2  
3700 S. Central  
Cicero, IL  
60804

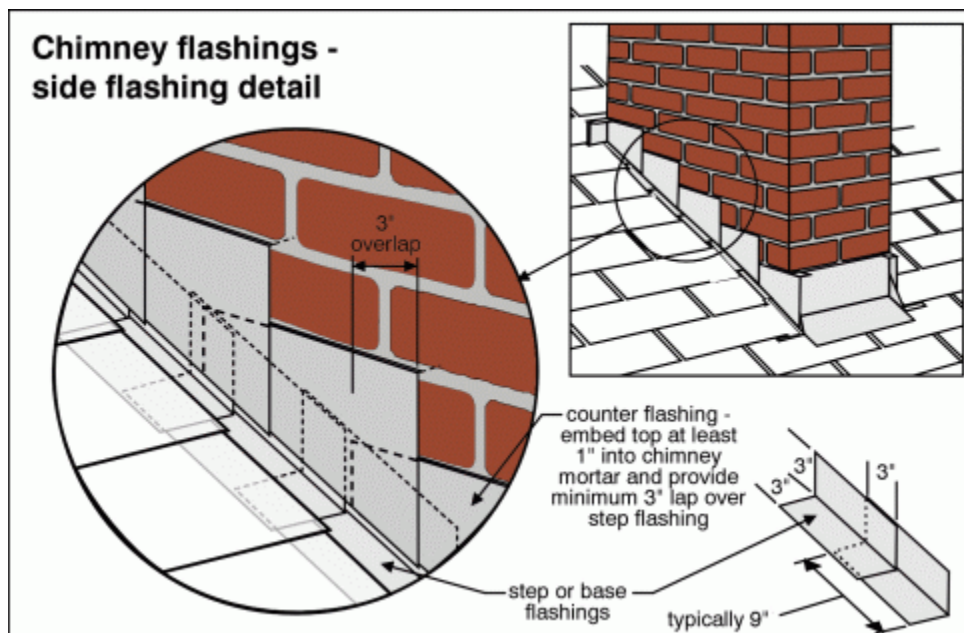
Chimney is "flashed" with tar. Although common, tar "flashing" is a problematic solution to roof leaks. This is a low-cost alternative to real chimney flashing. May leak unexpectedly; regular maintenance is needed to prevent roof leaks. You are encouraged to have the chimney properly flashed with metal flashing when replacing roof. Consult with licensed roofing contractor for repair estimates.

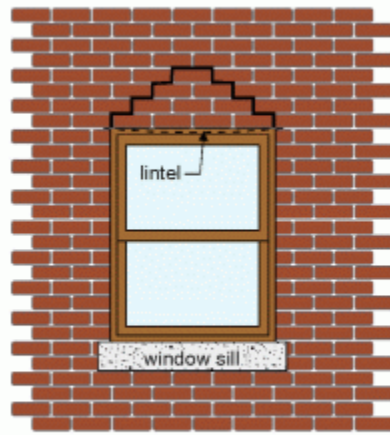
## Lintel related wall cracks

crack pattern commonly associated with sagging lintels due to undersizing or deterioration

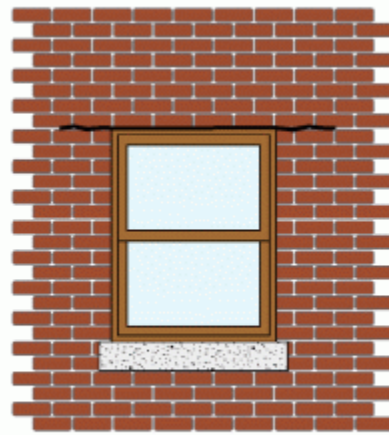
horizontal crack often caused by rusting steel lintels expanding

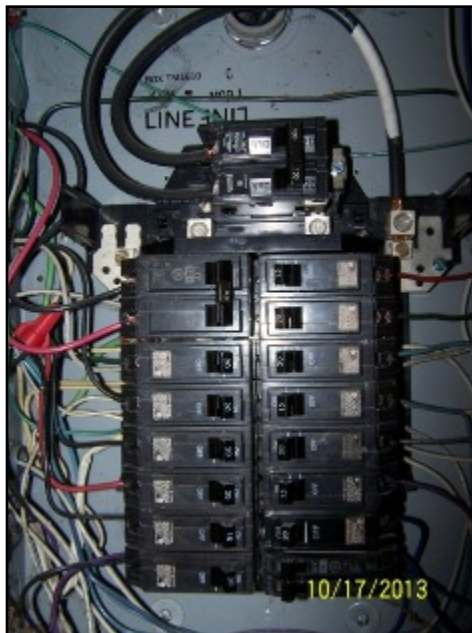
*Panel checked*

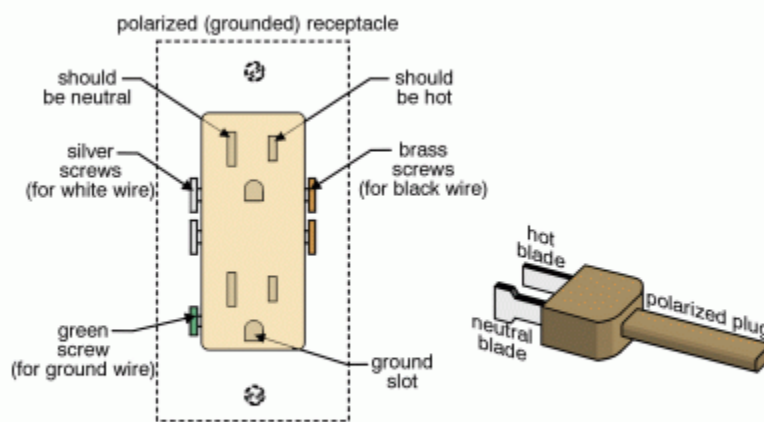
**Reversed polarity**

when the polarity is reversed, the wide receptacle slot is (incorrectly) hot and the narrow slot is neutral - this is not uncommon when people forget that the black wire should be attached to the receptacle's brass screws
